INSPECTION SUMMARY REPORT

Client: Junior and Jane CondoSample
Inspection Address: Seacrest Cliffs, Unit 515, Seacrest FL. 32413
Inspection Date: 04/28/2003 Start: 9:00am End: 11:30
Inspected by: JD Johnson

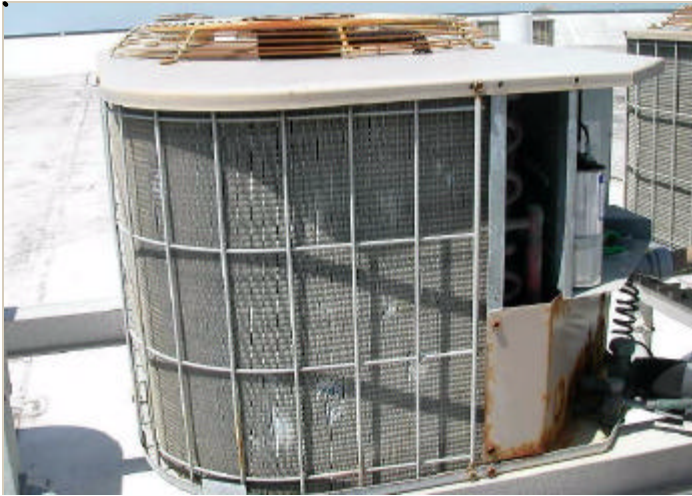
- The fins of the condensing coil have eroded due to the proximity to the Gulf and local environment. Typical life of a Gulf front unit is about 5 years. Therefore, this coil is nearing the end of its expected life. I recommend budgeting for a replacement within the next 2 years.

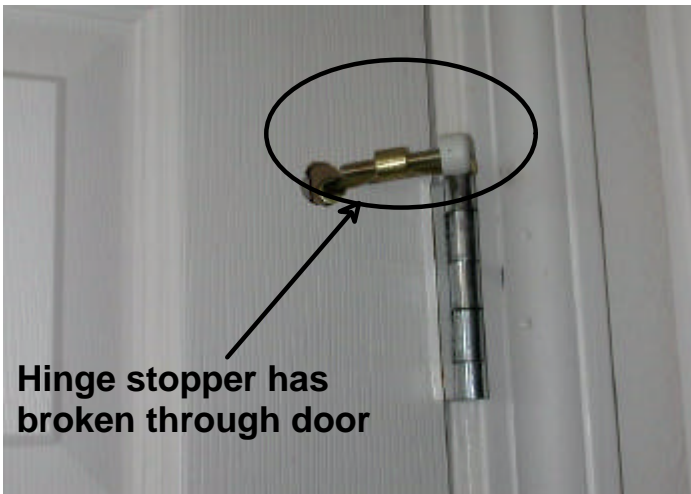
- The entry door is damaged and should be serviced. The door stop has pierced the door and is no longer effective. I recommend the door be fixed by a professional.
