INSPECTION SUMMARY REPORT

Client: Junior and Jane Sample
Inspection Address: 231 Commodore Way, Destin Florida.
Inspection Date: 04/10/2003 Start: 9:00am End: 1:30 pm
Inspected by: JD Johnson

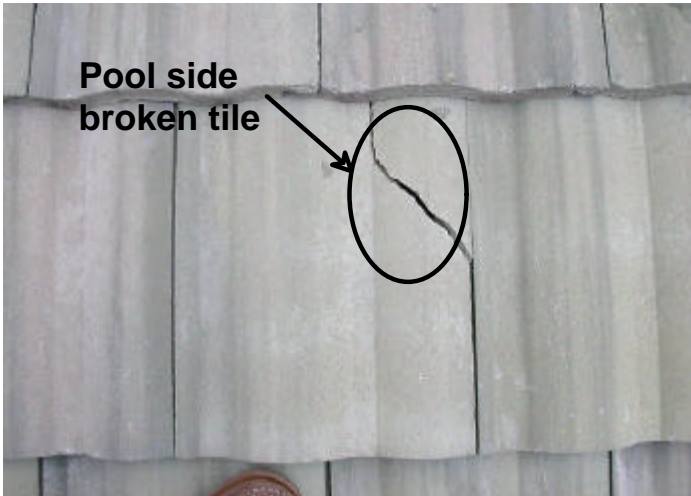
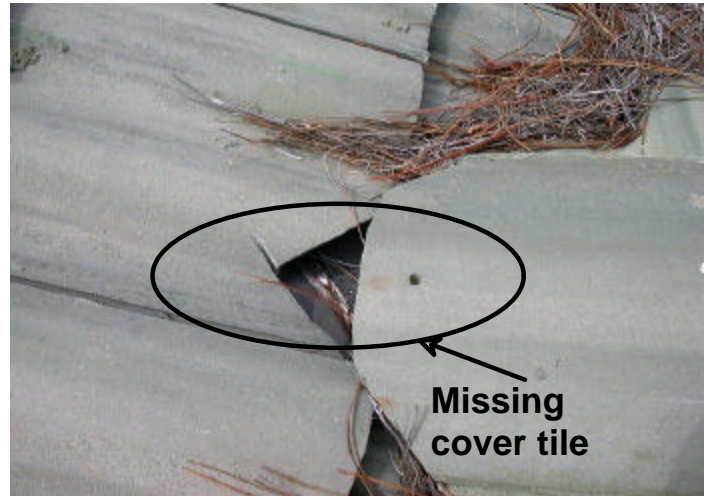
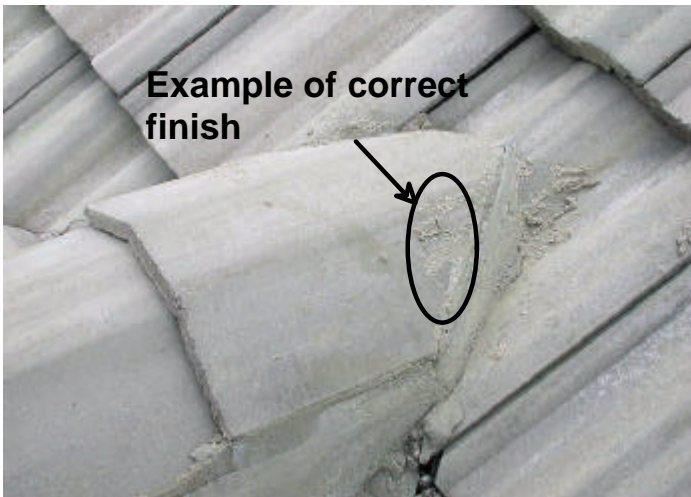
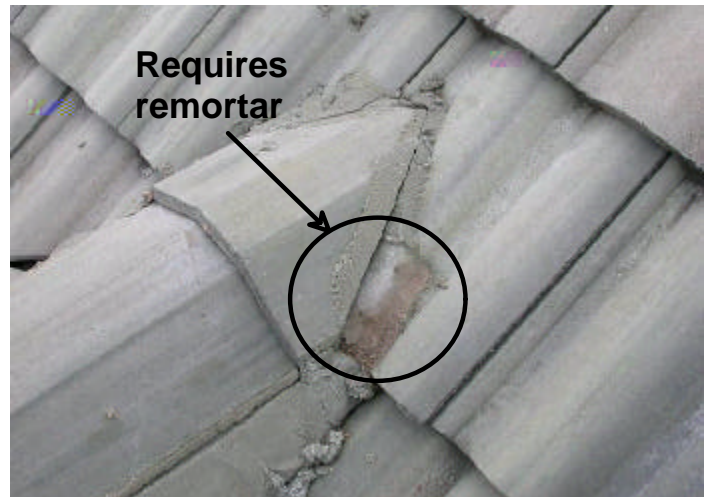
Damaged Tiles

- There are a number of cracked, broken, or displaced composite tiles, some of which have exposed the waterproof membrane. These tiles should be repaired or replaced by a roofing contractor before the close of escrow, and before the ultra-violet rays of the sun deteriorate the waterproof membrane and cause the roof to leak. Areas identified as requiring service include: The ridge cap over the garage. The house roof on the poolside (on the right side, 5 rows from the top) and mortar needs repointing in the front cap above the entrance.

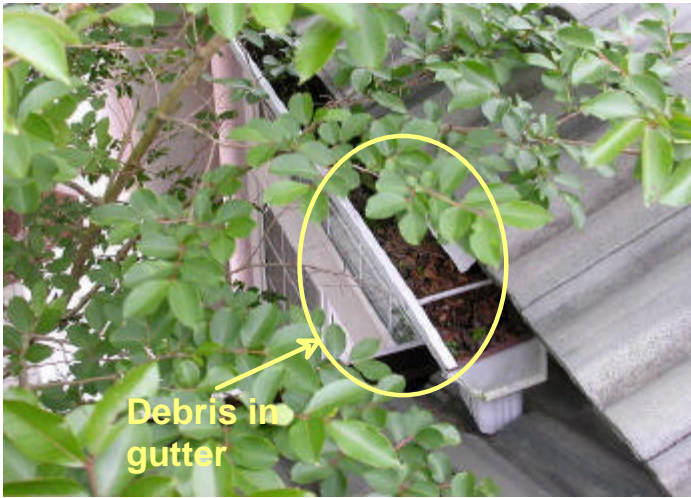
Gutters and Drainage

- The composite tile roof needs to be cleaned to drain effectively.
- The gutters on the composite tile roof will need to be cleaned to drain the roof effectively.

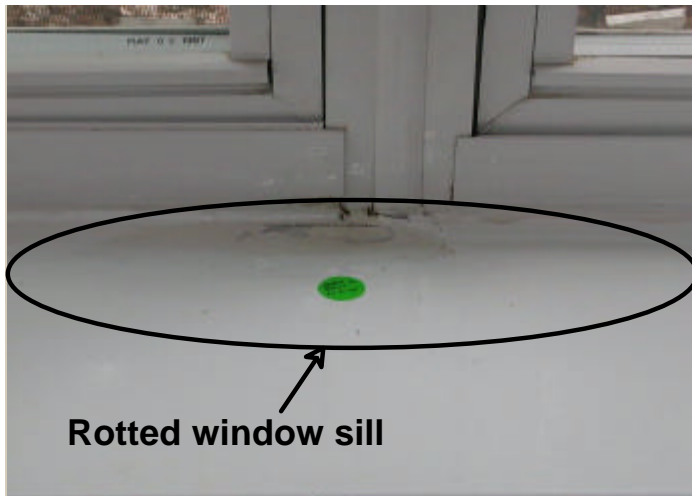
Dual-Glazed Windows

- The window sill under the openable windows is rotted. I did not need to damage the cosmetic paint on the surface to determine that a significant area of the sill is rotted. I recommend review of this area by a specialist to determine the moisture source. Most likely one or more of the windows is improperly flashed or sealed and is leaking into the home. Once the source is identified and corrected, the window sill can be repaired or replaced by a professional.

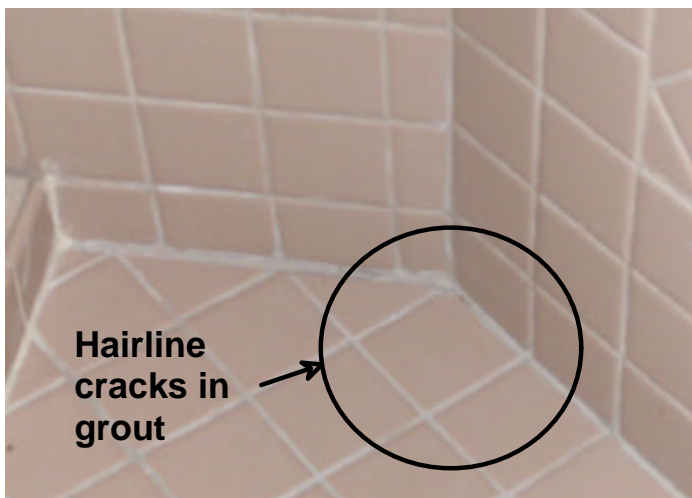
Stall Shower

- There are open grout-joints in the stall shower tiles that should be sealed to prevent moisture damage.

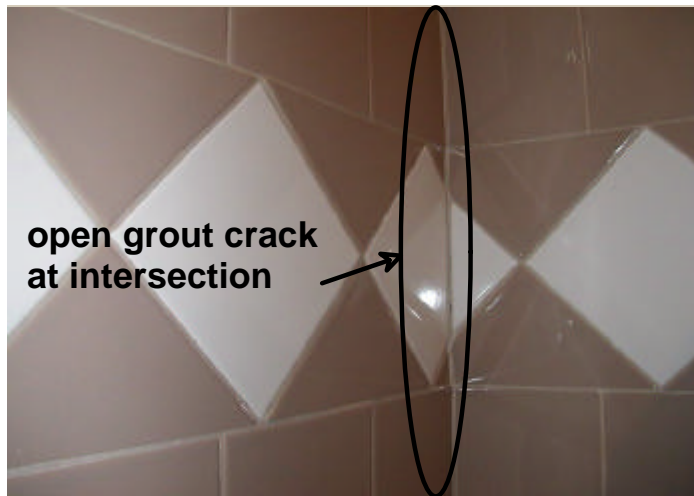
Tub-Shower

- There are open grout-joints in the tiles around the tub area in this bathroom that should be sealed to prevent moisture damage.
