Beach to Bayou

PROPERTY INSPECTIONS

INSPECTION REPORT

100 Homeowner Street

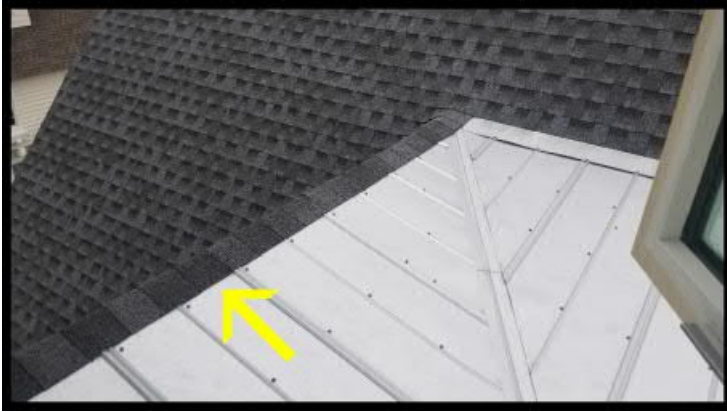
There is a roof ridge that is atypically capped with asphalt shingles when metal panels are typically used. This application may allow wind to get below these shingles and pull them off. I recommend the application be reviewed and either approved in writing or corrected as appropriate.

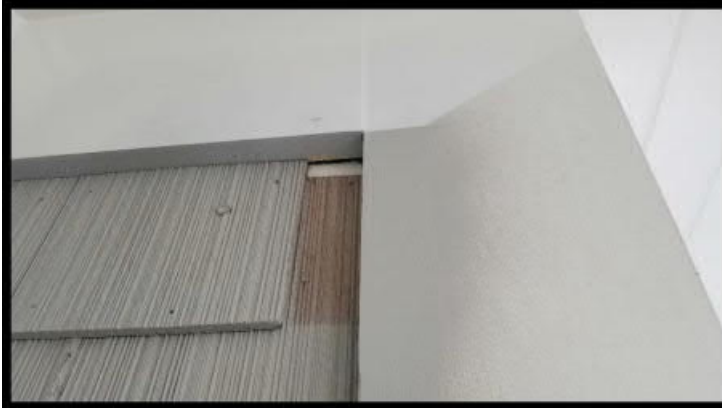
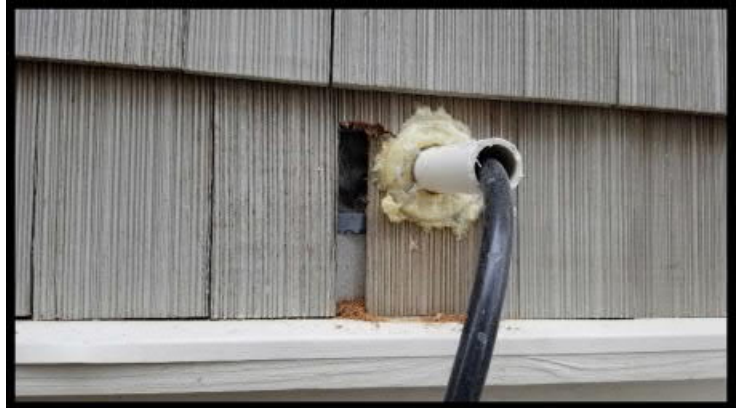
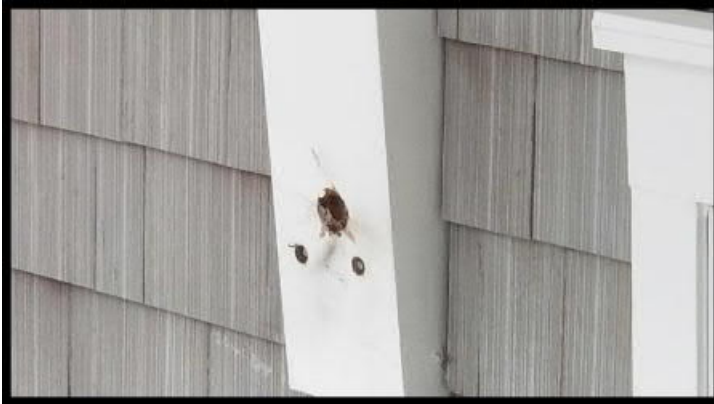
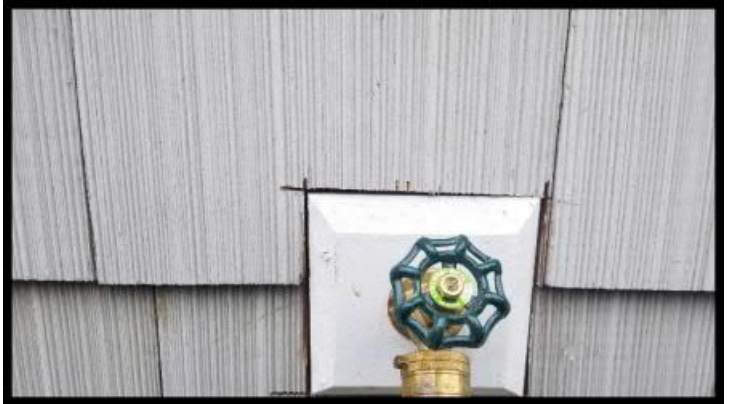
There are missing siding shingles on the 4th Level deck and northeast corner of the 1st level that need to be replaced.

During the inspection, we identified unsealed wall and trim penetrations. As our inspection is not exhaustive, we recommend all wall penetrations, such as window frames, hose bibs, utility boxes, wires and similar points of entry, be reviewed by a specialist and all deficient areas sealed to protect against moisture and insect intrusion.

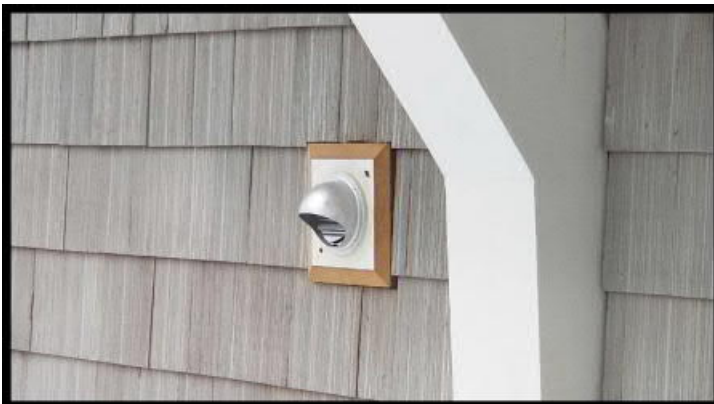
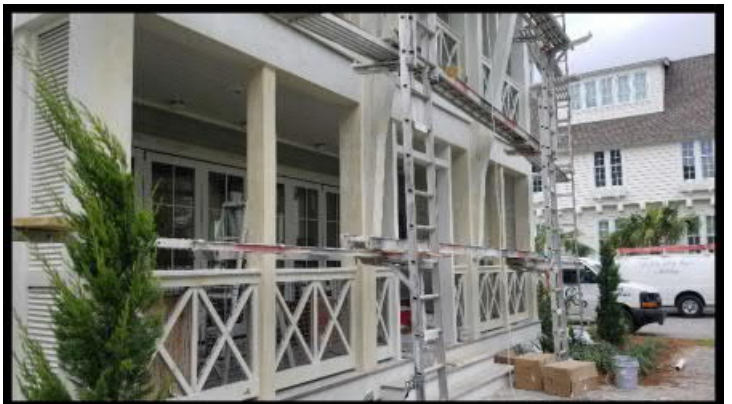
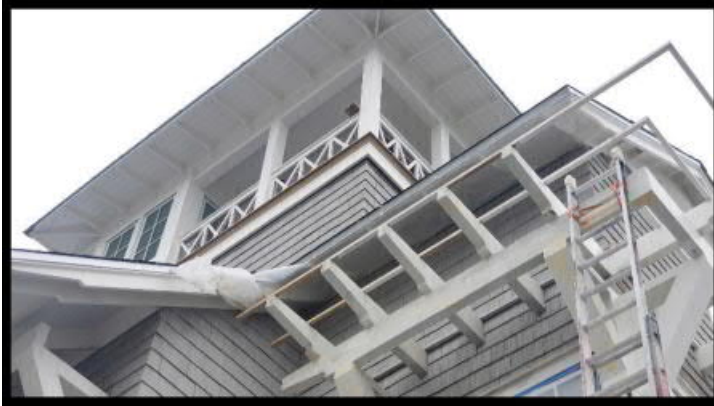
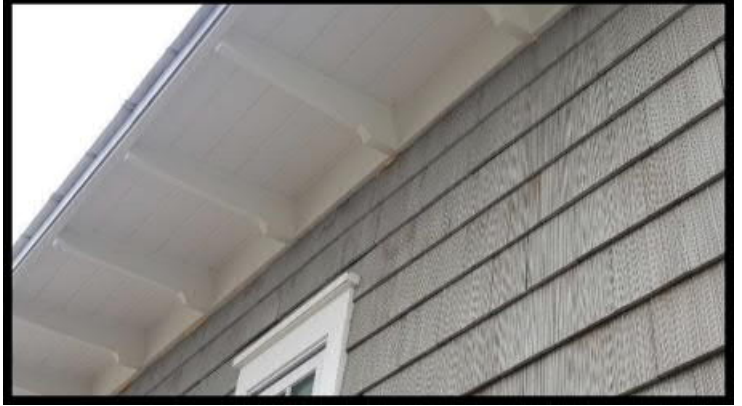
There are multiple examples of unfinished, unpainted and unsealed trim components, all of which need to be completed and reviewed for defect before the close of sale.

There are multiple examples of spray foam insulation seeping out along the soffit which needs to be cut back and finished as intended.

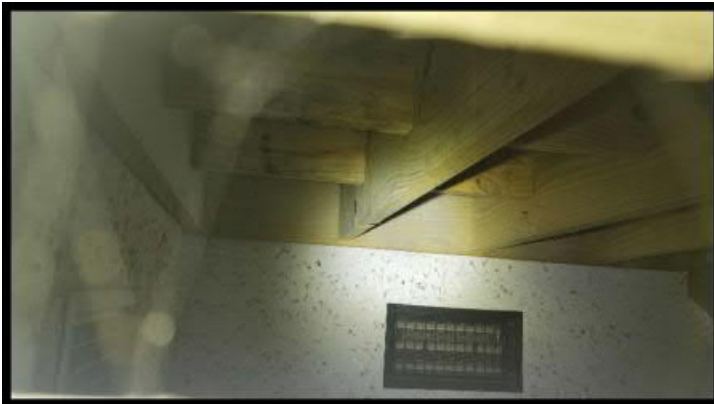
The main entry deck joists are typically required to have hanger brackets or a ledger board but neither are present. I recommend this application be reviewed and either approved in writing or corrected as appropriate.

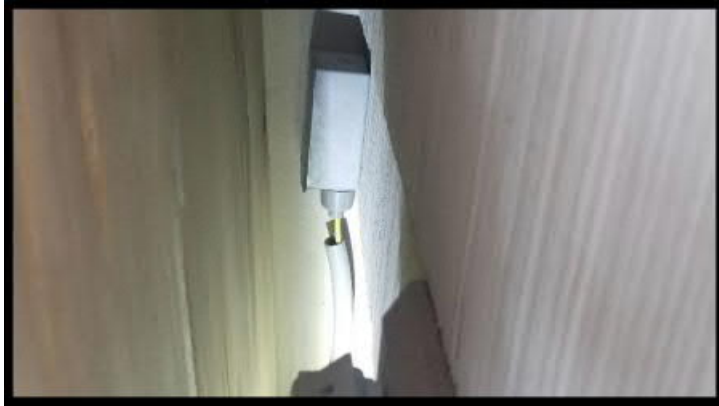
The electrical receptacle located on the east side of the 1st Level north deck is obstructed by cabinetry and will need to be serviced as appropriate to allow access as designed.

There is a separated water tight electrical conduit on the east side of the 1st Level north deck which needs to be repaired as appropriate.

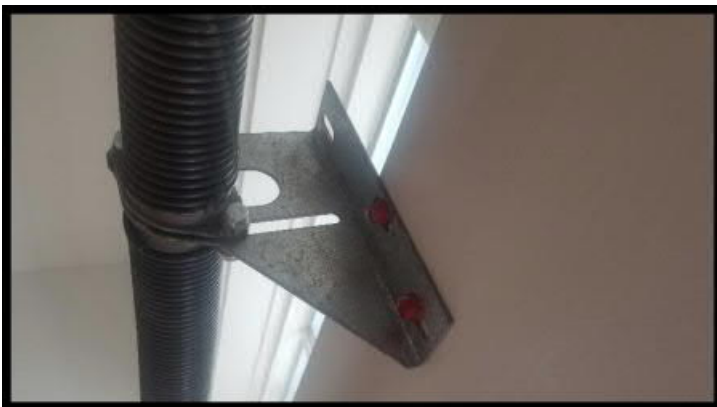
The garage door is missing weather stripping that need to be installed to prevent moisture and pest intrusion.

The tension spring bracket is only secured with 2 screws when 3 holes are present. I recommend this application be reviewed and either approved or corrected as appropriate.

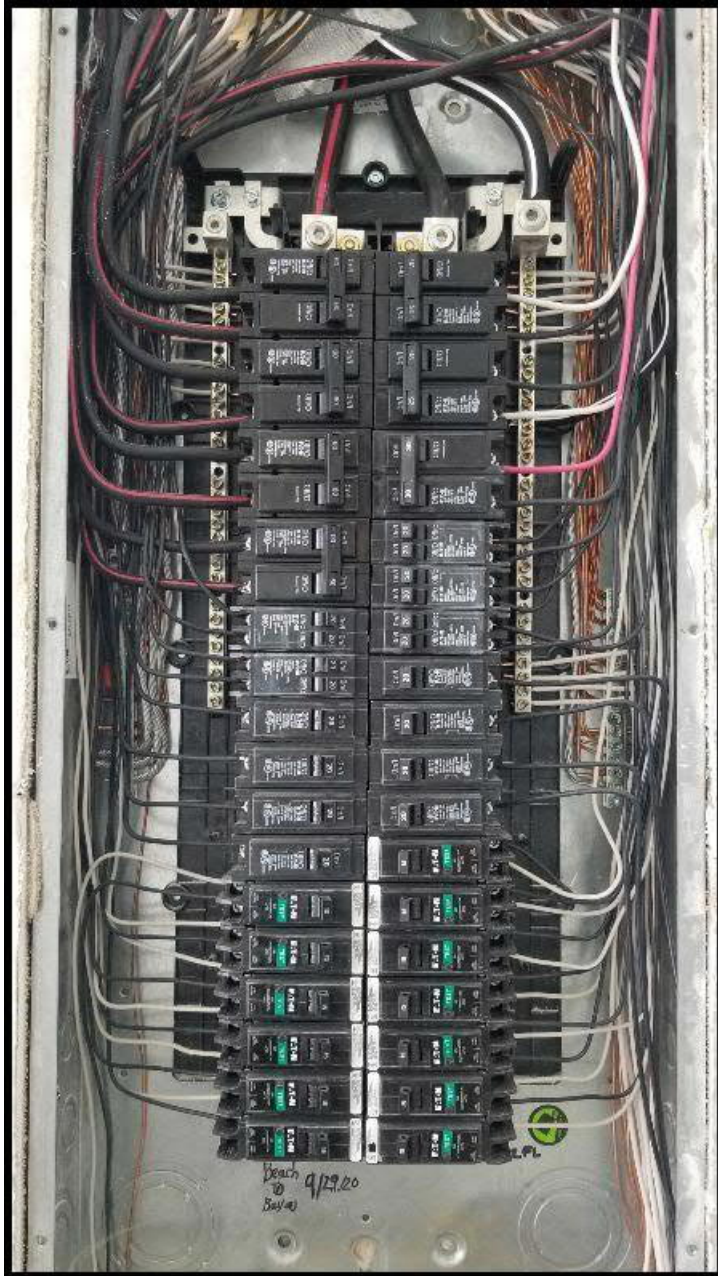
The panel cover is improperly secured with self tapping screws which can penetrate electrical wires and need to be replaced with a blunt tip version.

There is no visible anti-oxidation paste on the aluminum strand electrical connections which I recommend be reviewed and corrected by a licensed electrician.

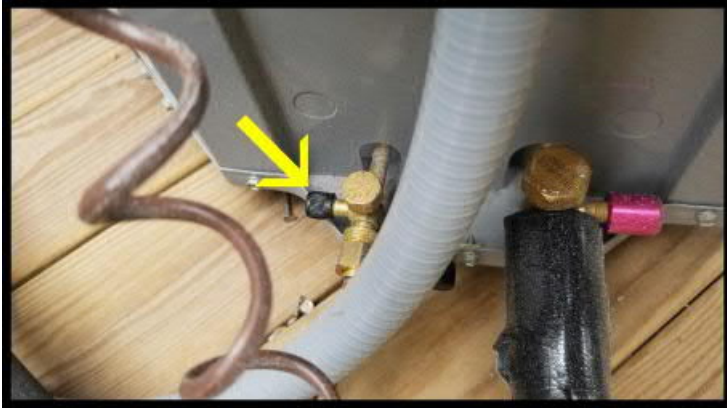
A refrigerant line valve does not include the required locking cap, which has been required since 2015. This application should be corrected to meet the standard.

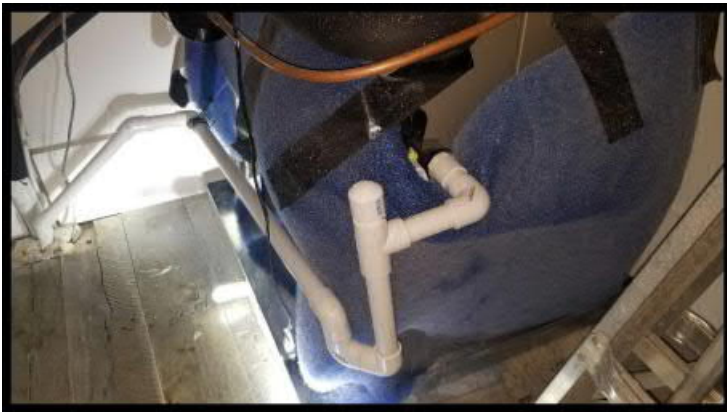
There is no secondary float switch installed on the primary condensate line which needs to be corrected as appropriate.

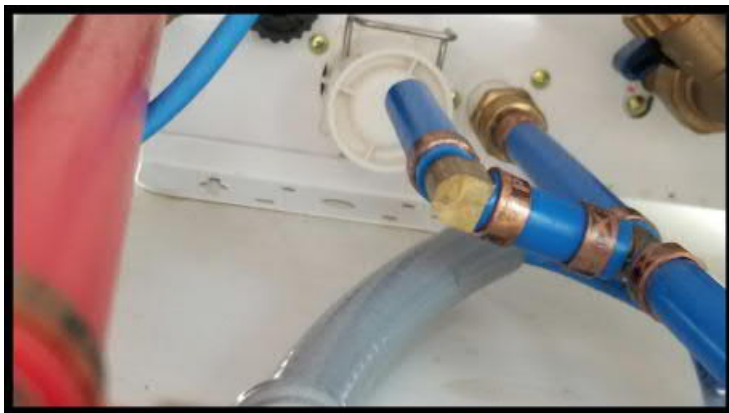
The south water heater is not secured at its bottom bracket which needs to be corrected as intended.

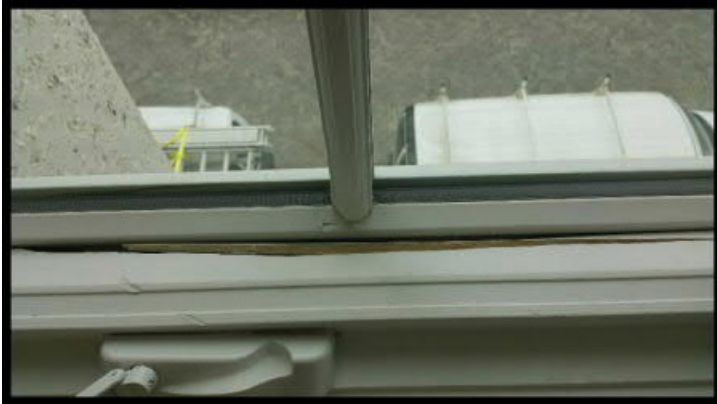
The west window in the north west corner has broken casing that needs service.

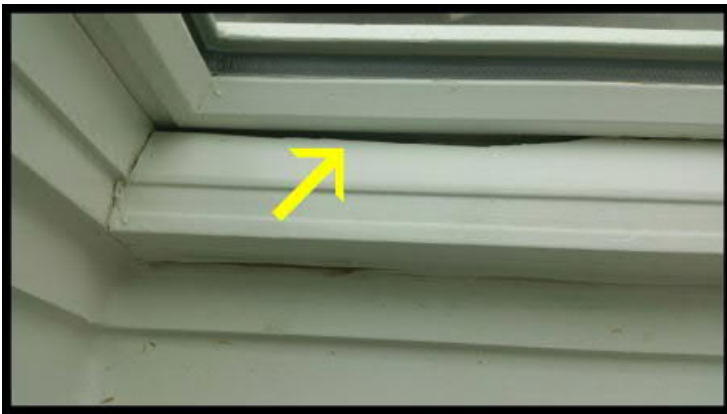
The left corner window has damaged casement trim.

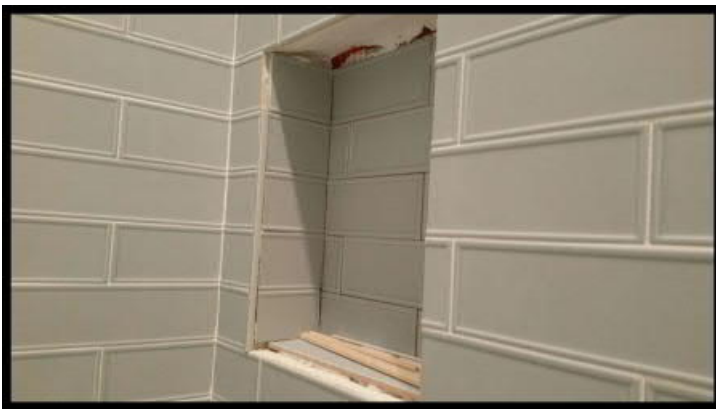
The tile work is incomplete at the wall niche and needs finished.

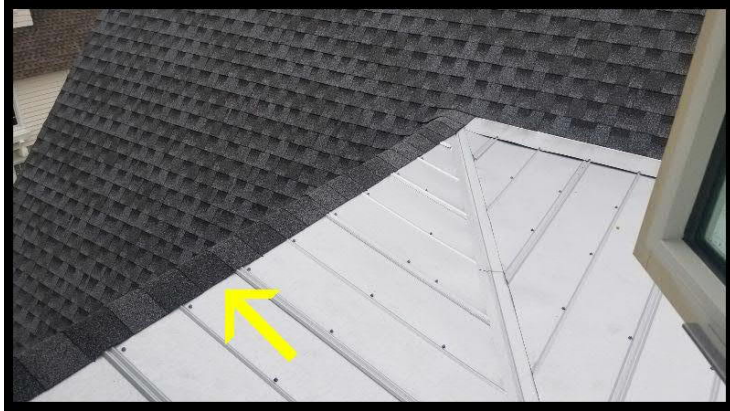
There are missing siding shingles on the 4th Level deck and northeast corner of the 1st level that need to be replaced.

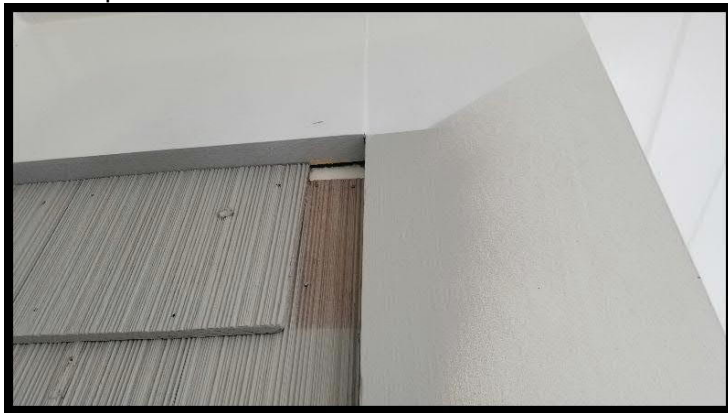
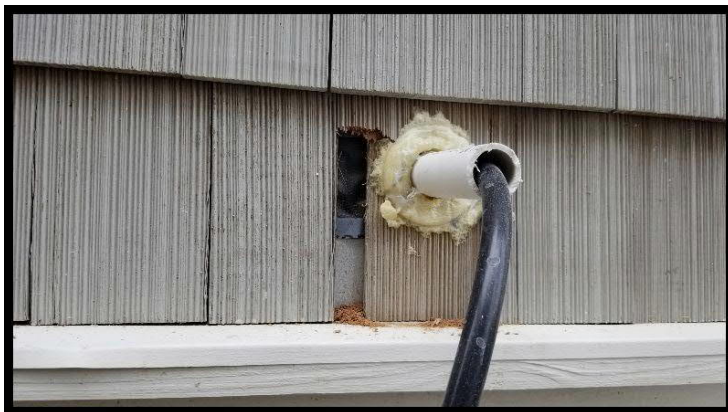
During the inspection, we identified unsealed wall and trim penetrations. As our inspection is not exhaustive, we recommend all wall penetrations, such as window frames, hose bibs, utility boxes, wires and similar points of entry, be reviewed by a specialist and all deficient areas sealed to protect against moisture and insect intrusion.

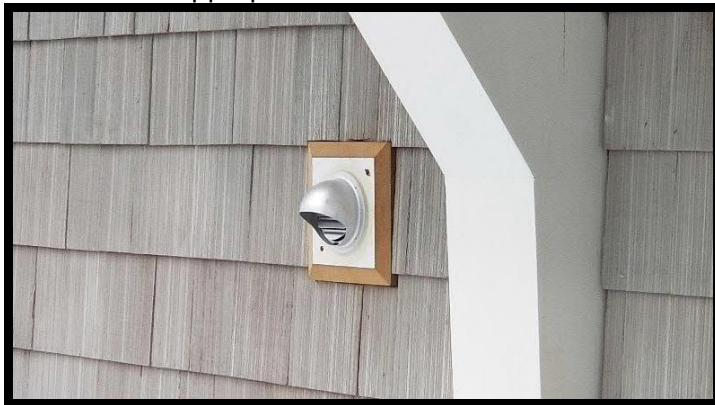
There are multiple examples of unpainted or unfinished exhaust vent and hose bib trim that needs to be corrected as appropriate.

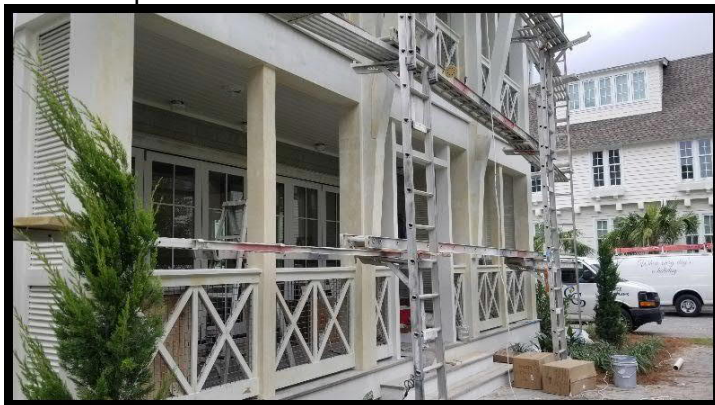
There are multiple examples of unfinished, unpainted and unsealed trim components, all of which need to be completed and reviewed for defect before the close of sale.

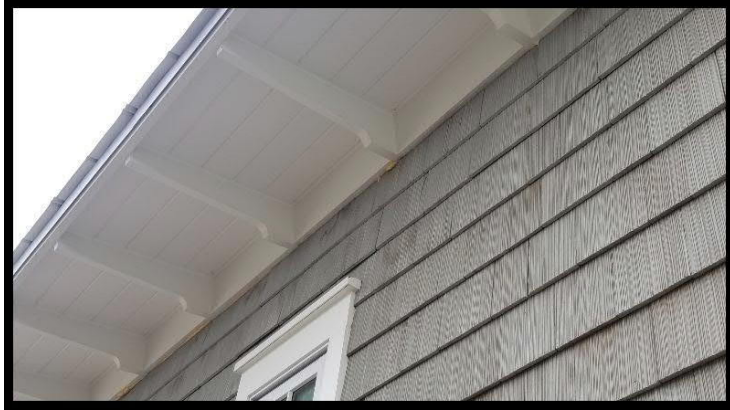
There are multiple examples of spray foam insulation seeping out along the soffit which needs to be cut back and finished as intended.

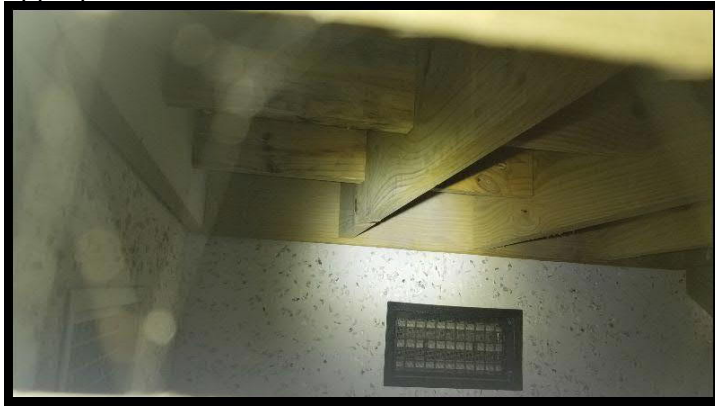
The main entry deck joists are typically required to have hanger brackets or a ledger board but neither are present. I recommend this application be reviewed and either approved in writing or corrected as appropriate.

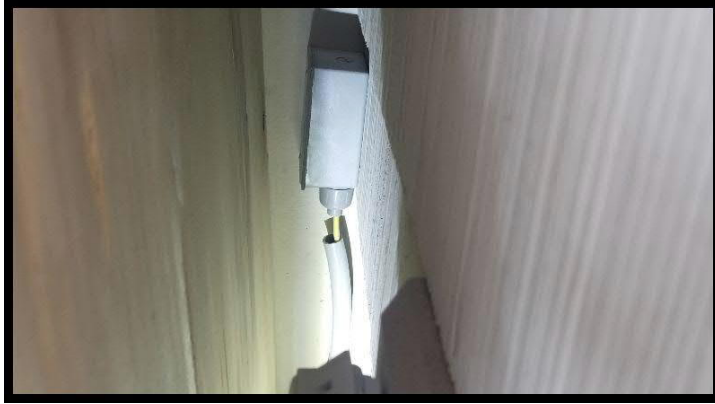
There is a separated water tight electrical conduit on the east side of the 1st Level north deck which needs to be repaired as appropriate.

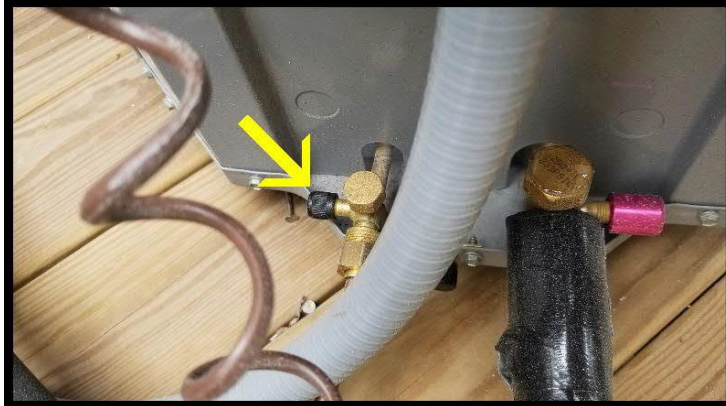
A refrigerant line valve does not include the required locking cap, which has been required since 2015. This application should be corrected to meet the standard.

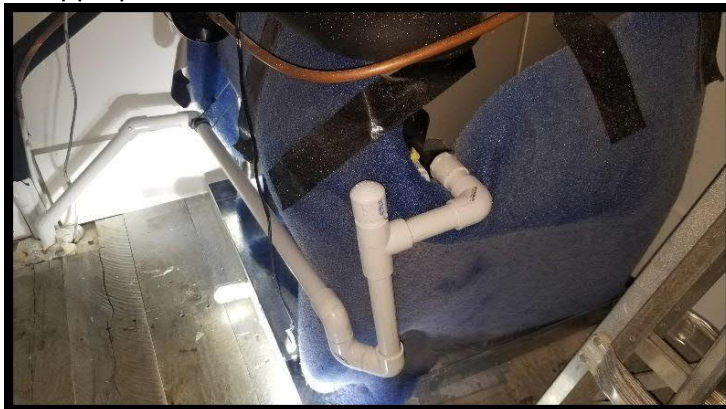
There is no secondary float switch installed on the primary condensate line which needs to be corrected as appropriate.

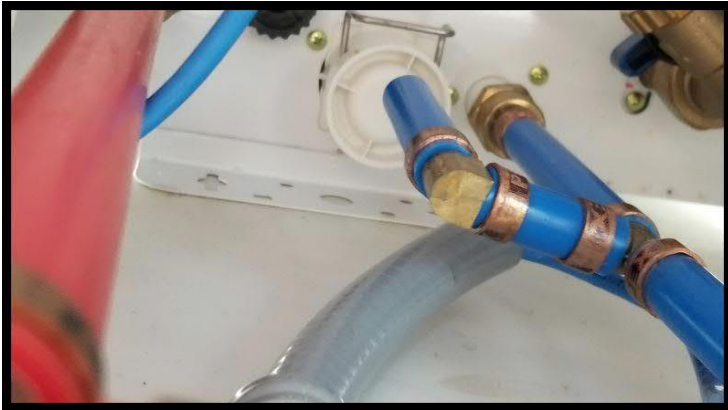
The south water heater is not secured at its bottom bracket which needs to be corrected as intended.

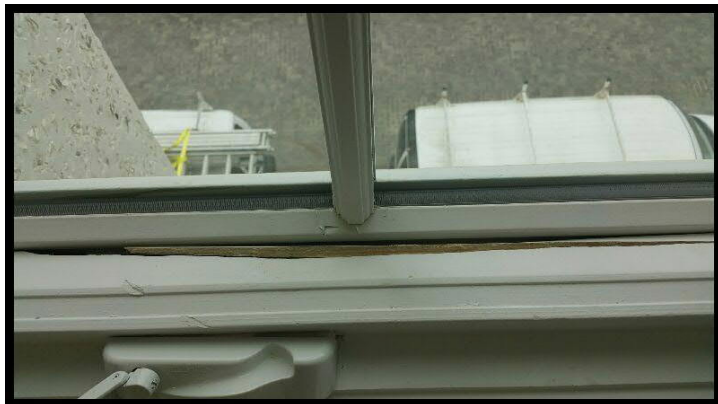
The west window in the north west corner has broken casing that needs service.

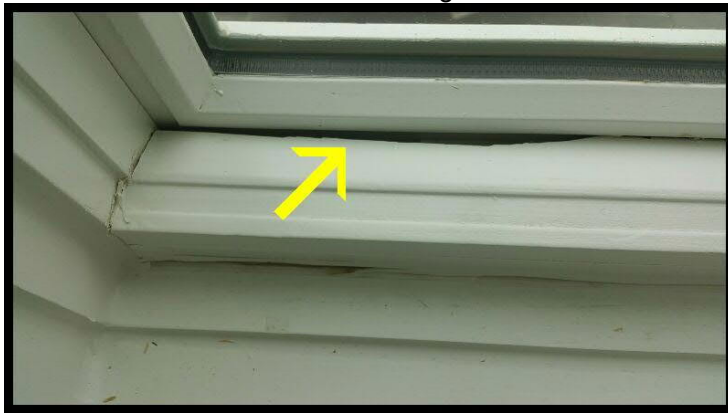
The left corner window has damaged casement trim.

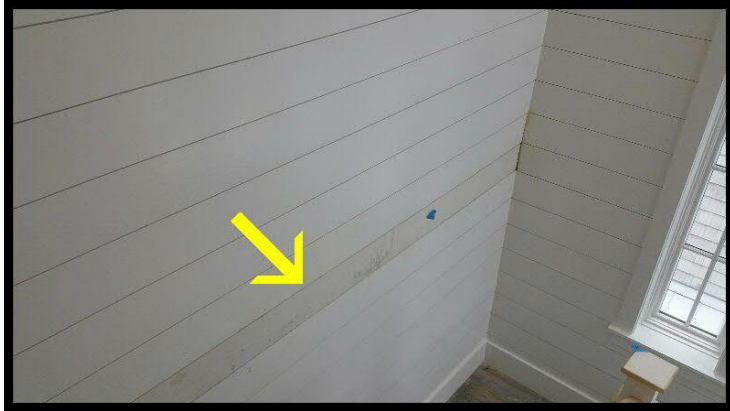
A section of the wall is under repair and should be completed.
