CONFIDENTIAL INSPECTION REPORT
PREPARED FOR:
Junior and Jane CondoSample

INSPECTION ADDRESS
Seacrest Cliffs, Unit 515, Seacrest, FL. 32413

INSPECTION DATE
04/28/2003 9:00am to 11:30

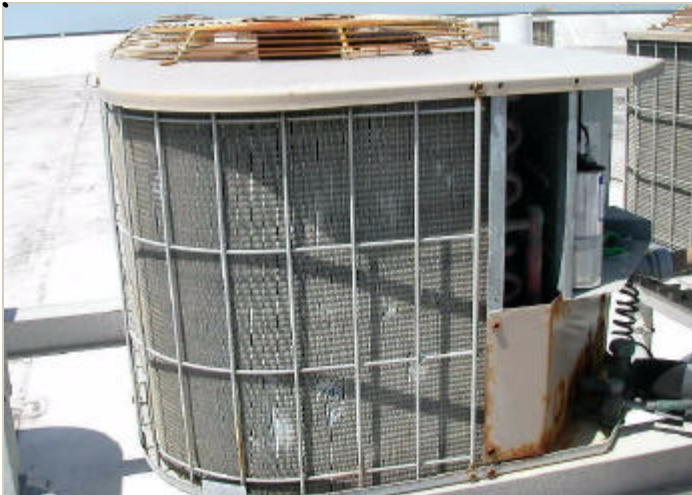
Condensing Coil

The fins of the condensing coil have eroded due to the proximity to the Gulf and local environment. Typical life of a Gulf front unit is about 5 years. Therefore, this coil is nearing the end of its expected life. I recommend budgeting for a replacement within the next 2 years.

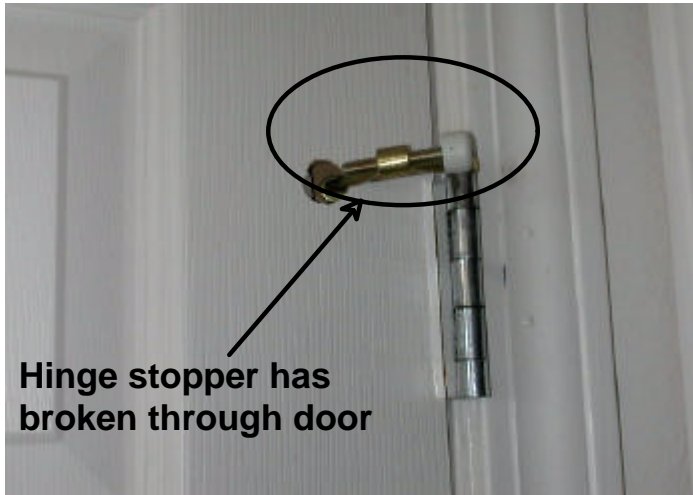
The entry door is damaged and should be serviced. The door stop has pierced the door and is no longer effective. I recommend the door be fixed by a professional.
