INSPECTION REPORT

100 Homeowner Cove Unit A1, Inlet Beach, FL

2/00/2021

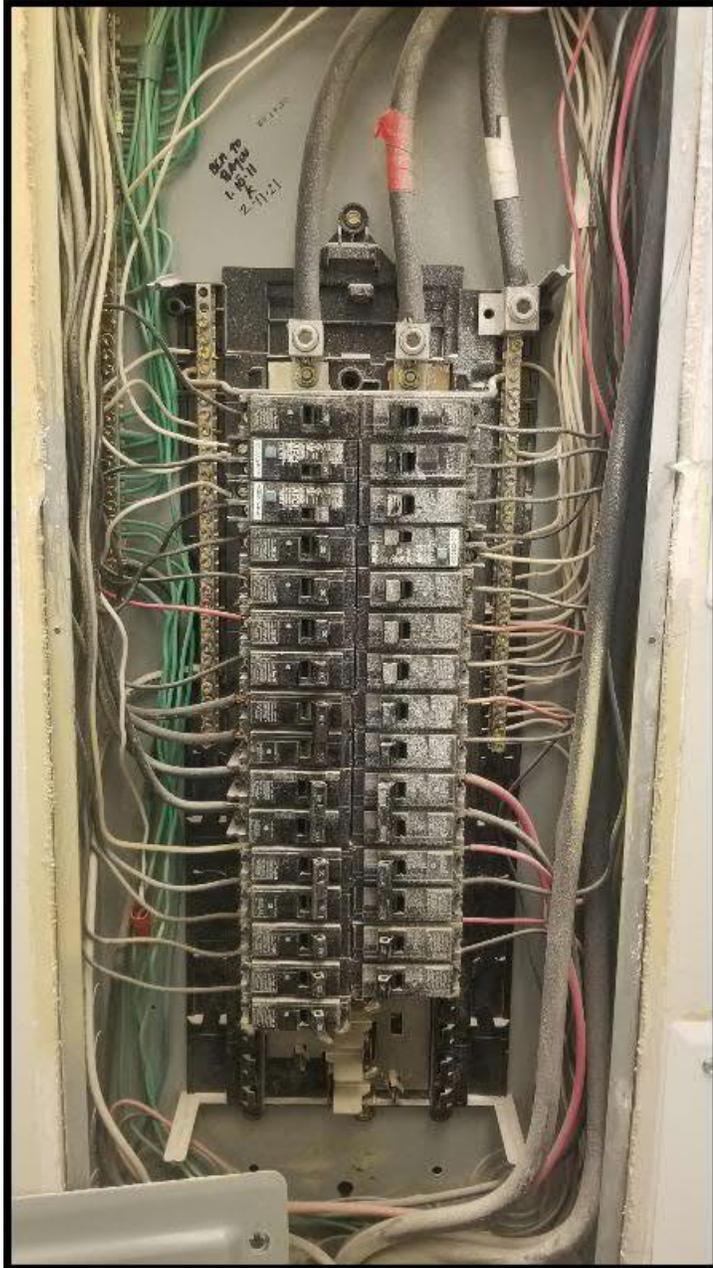
2.5 Sub Panel Observations

The electrical sub panel has no visible deficiencies.

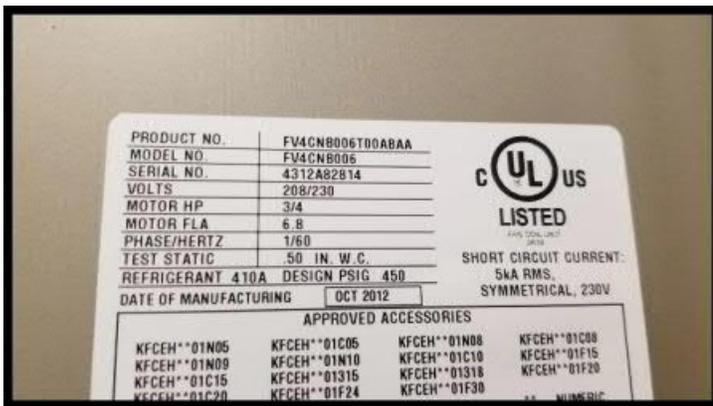
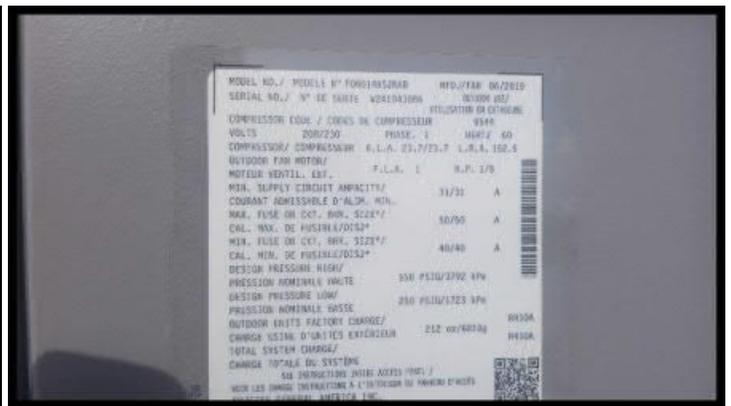
A central air handler / electric furnace unit, which is located in the utility closet The Air Handler Unit (AHU) was manufactured by Carrier in about 2012 .

And an approximately 5 ton condensing unit, which is located on the rooftop of the building The A/C coil was manufactured by Fujitsu in about 2019 .

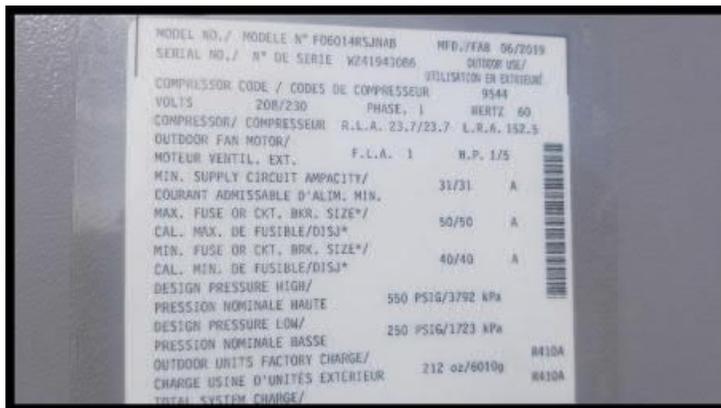
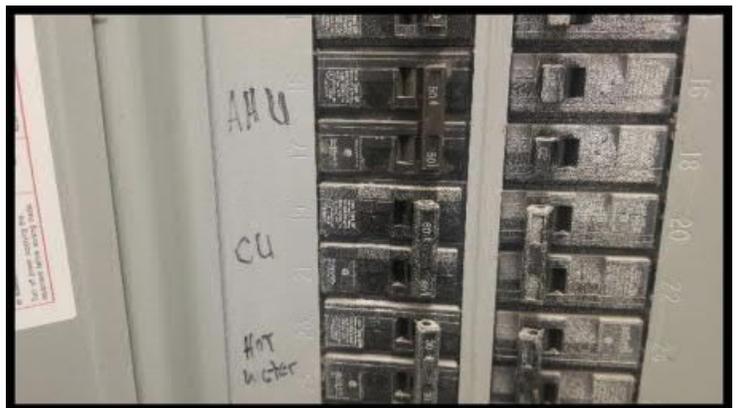
The breaker / disconnect for the condensing coil is oversized, in accordance with the manufactures name plate rating. This condition can cause damage to the unit, and should be reviewed and corrected by a professional, licensed electrician.

The breaker is a 60 amp and the nameplate rating is listed at maximum 50 amp.

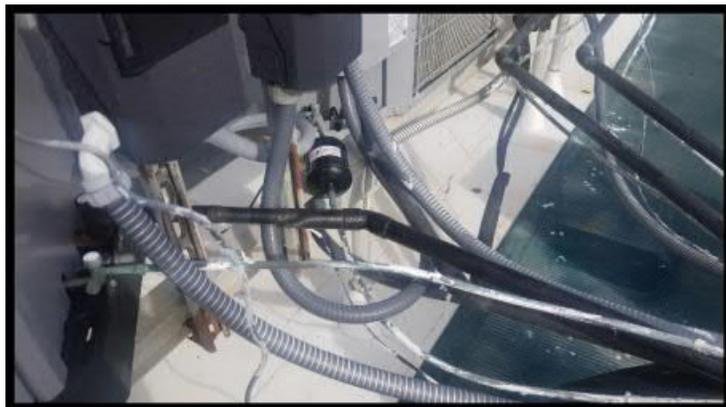
3.5 Refrigerant Lines

Insulation is missing from the refrigerant line at the exterior coil. This condition should be corrected to ensure maximum efficiency and reduce potential for moisture related damage (due to condensation).

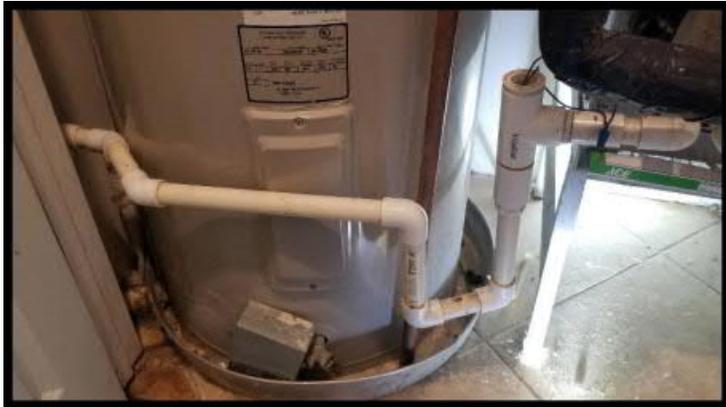
3.6 Condensate Discharge Pipe

The condensate discharge pipe is improperly ran across the water heater element cover. I recommend the pipe be relocated to allow servicing of the water heater.

I was unable to access the lower heating element at the time of inspection due to the HVAC condensate discharge pipe being plumbed across its cover. I recommend this element be reviewed for defect once accessible.

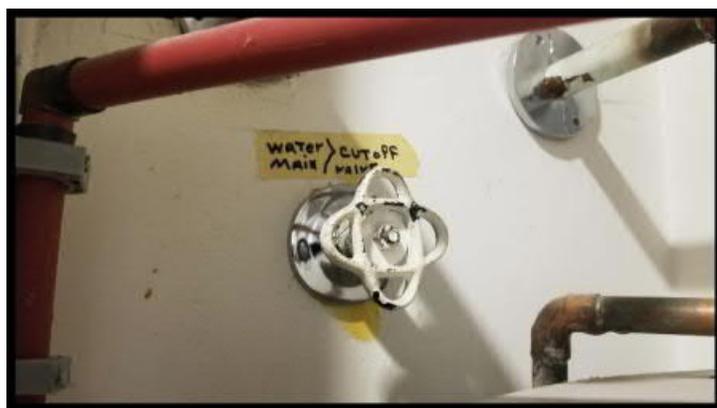
4.1 Water Main Location

The main water shut-off valve for this residence is located adjacent to the water heater.

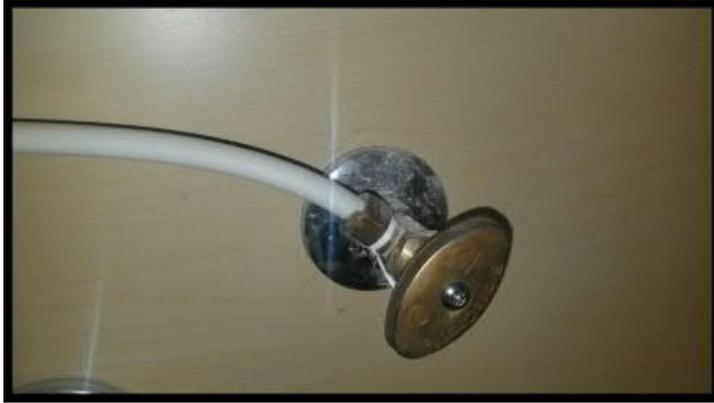
6.8 Sink Components

The east sink cold water shutoff valve is leaking and needs to be repaired.

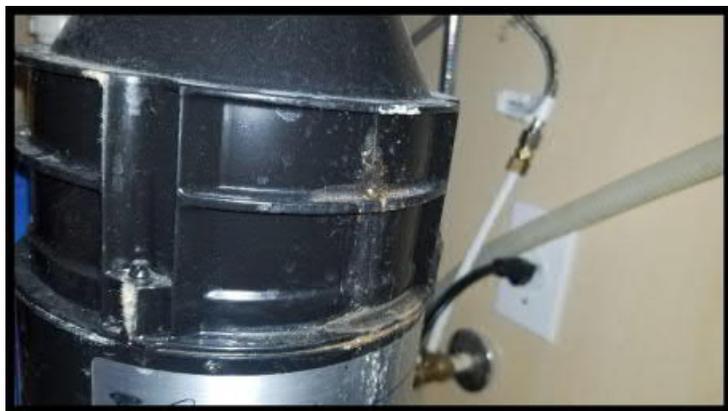
8.8 Garbage Disposal

The disposal housing has fractured and is leaking. The appliance should be replaced to restore proper functionality.

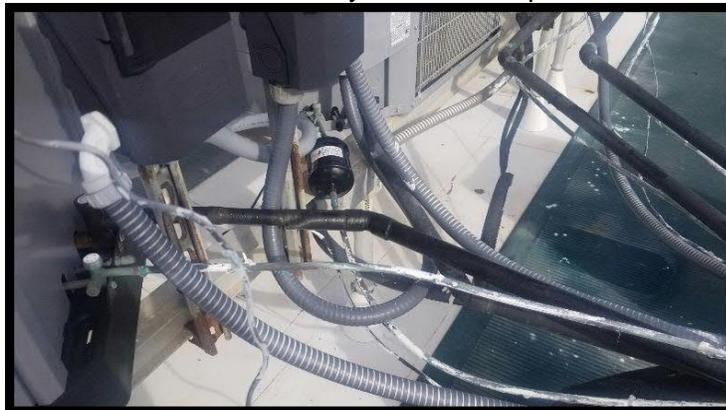
3.5 Refrigerant Lines

Insulation is missing from the refrigerant line at the exterior coil. This condition should be corrected to ensure maximum efficiency and reduce potential for moisture related damage (due to condensation).

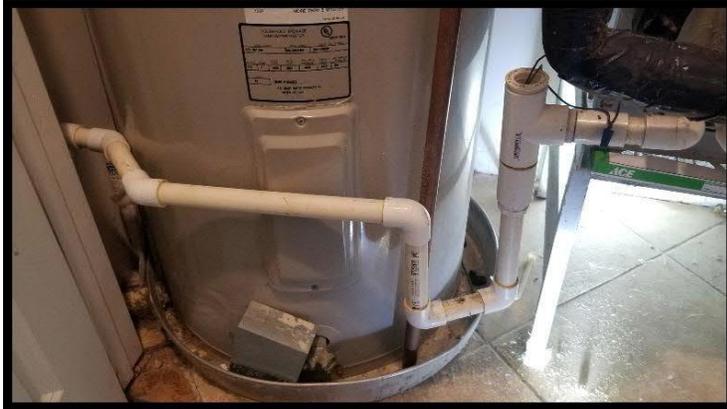
3.6 Condensate Discharge Pipe

The condensate discharge pipe is improperly ran across the water heater element cover. I recommend the pipe be relocated to allow servicing of the water heater.

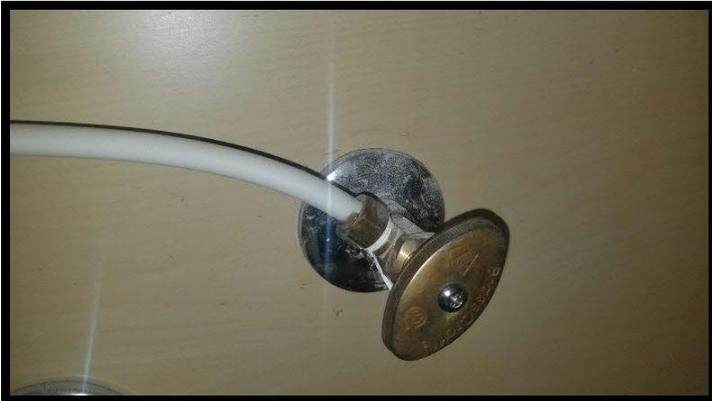
6.8 Sink Components

The east sink cold water shutoff valve is leaking and needs to be repaired.
