PROPERTY INSPECTIONS

INSPECTION REPORT

100 Homeowner Cove Unit A1, Inlet Beach, FL

2/01/2021

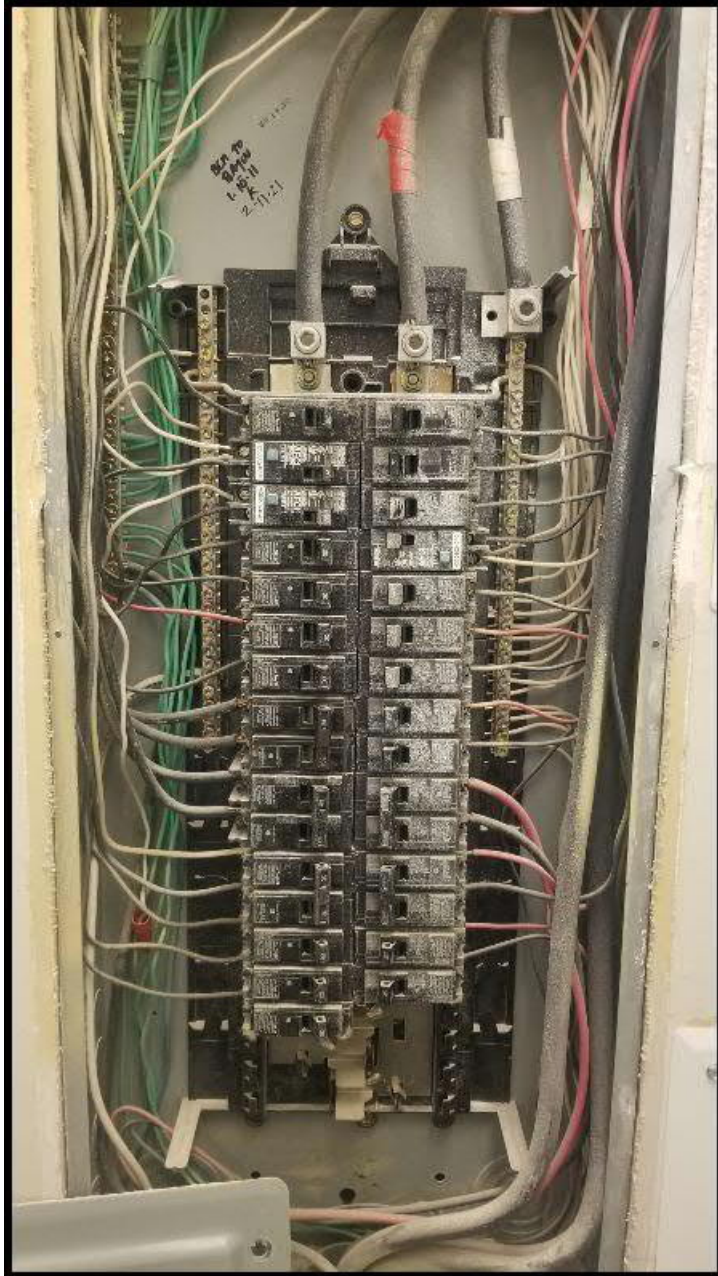
2.5 Sub Panel Observations

The electrical sub panel has no visible deficiencies.

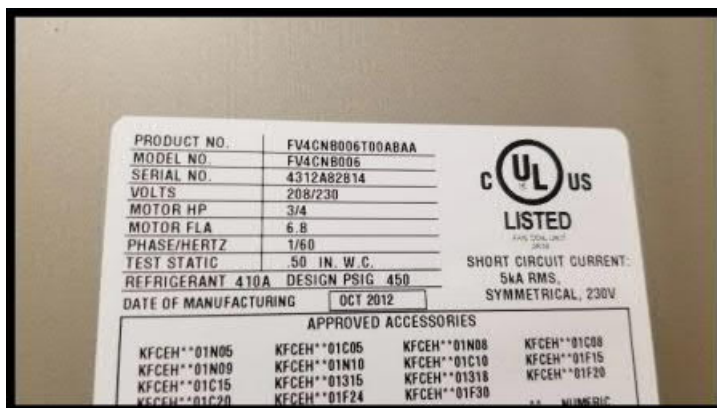
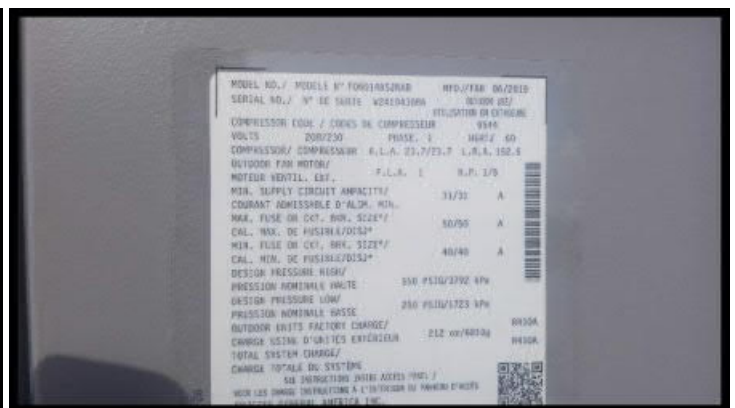
A central air handler / electric furnace unit, which is located in the utility closet The Air Handler Unit (AHU) was manufactured by Carrier in about 2012 .

And an approximately 5 ton condensing unit, which is located on the rooftop of the building The A/C coil was manufactured by Fujitsu in about 2019 .

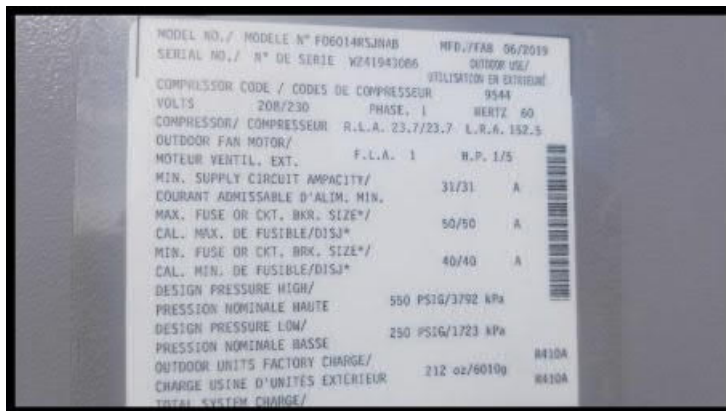
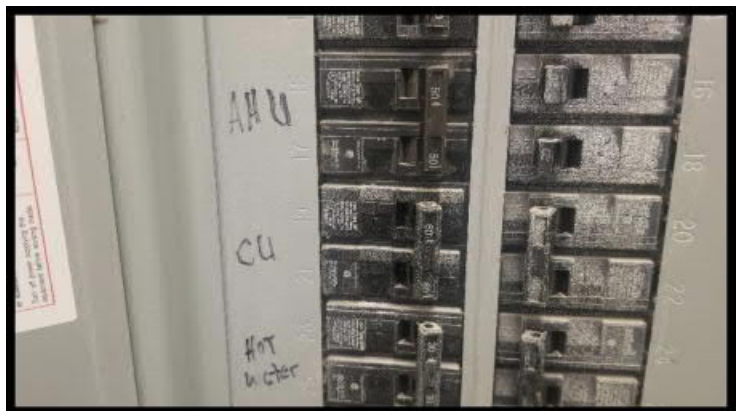
The breaker / disconnect for the condensing coil is oversized, in accordance with the manufactures name plate rating. This condition can cause damage to the unit, and should be reviewed and corrected by a professional, licensed electrician.

The breaker is a 60 amp and the nameplate rating is listed at maximum 50 amp.

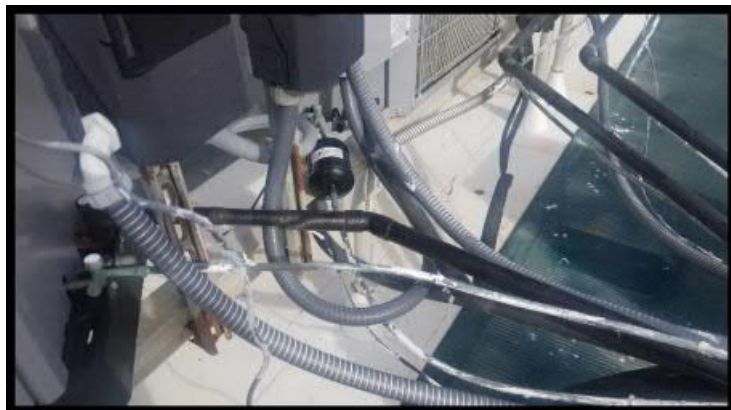
3.5 Refrigerant Lines

Insulation is missing from the refrigerant line at the exterior coil. This condition should be corrected to ensure maximum efficiency and reduce potential for moisture related damage (due to condensation).

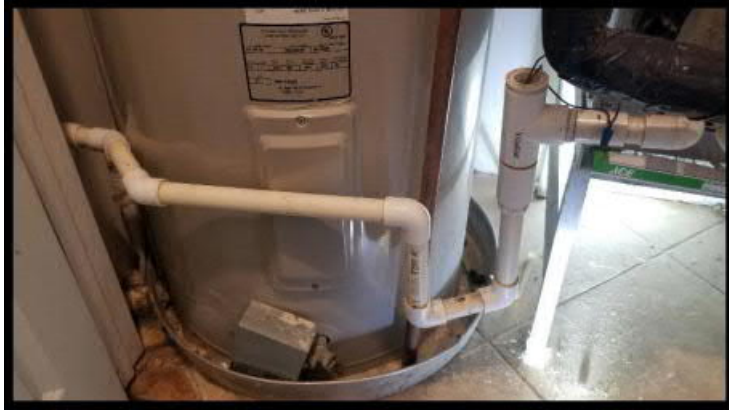
3.6 Condensate Discharge Pipe

The condensate discharge pipe is improperly ran across the water heater element cover. I recommend the pipe be relocated to allow servicing of the water heater.

I was unable to access the lower heating element at the time of inspection due to the HVAC condensate discharge pipe being plumbed across its cover. I recommend this element be reviewed for defect once accessible.

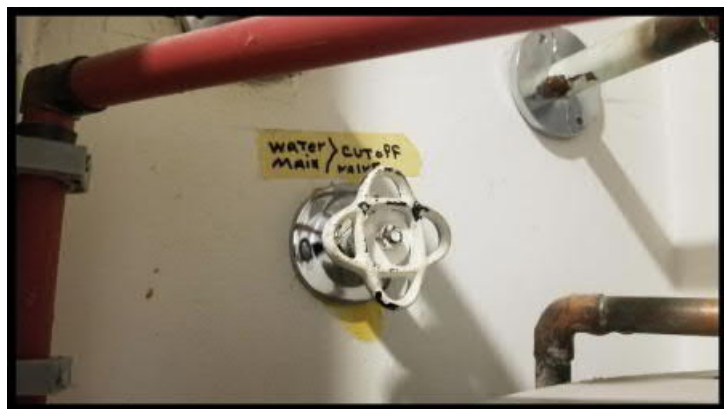
4.1 Water Main Location

The main water shut-off valve for this residence is located adjacent to the water heater.

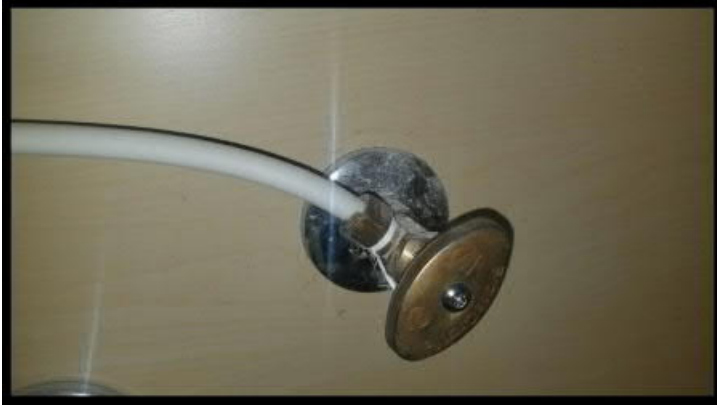
6.8 Sink Components

The east sink cold water shutoff valve is leaking and needs to be repaired.

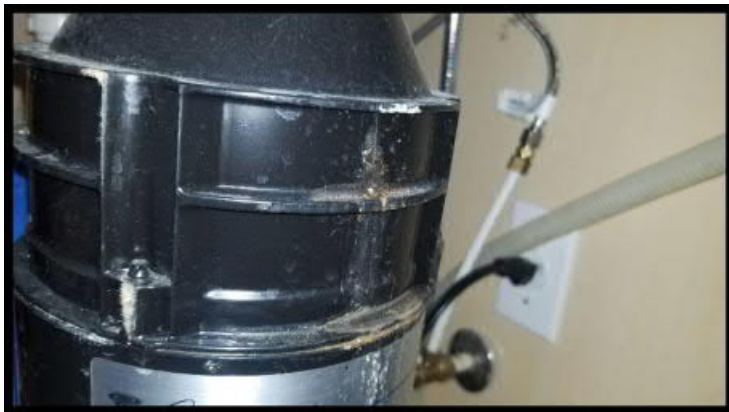
8.8 Garbage Disposal

The disposal housing has fractured and is leaking. The appliance should be replaced to restore proper functionality.

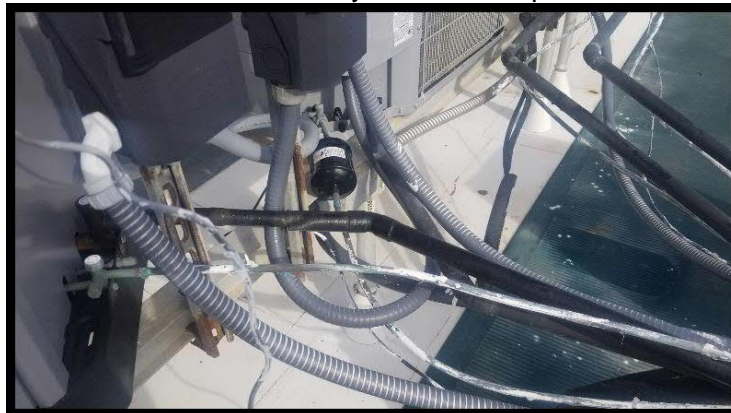
3.5 Refrigerant Lines

Insulation is missing from the refrigerant line at the exterior coil. This condition should be corrected to ensure maximum efficiency and reduce potential for moisture related damage (due to condensation).

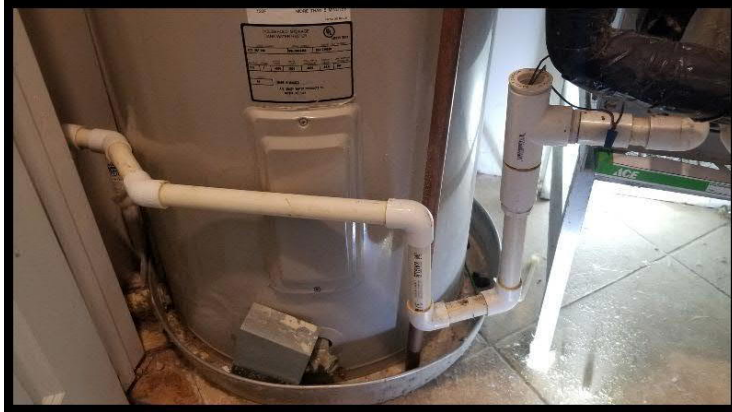
3.6 Condensate Discharge Pipe

The condensate discharge pipe is improperly ran across the water heater element cover. I recommend the pipe be relocated to allow servicing of the water heater.

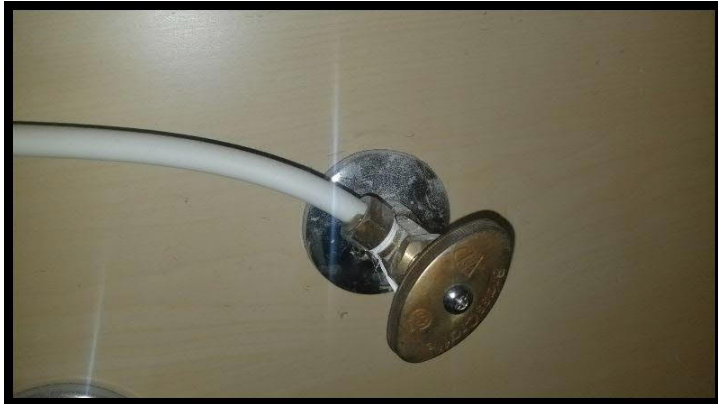
6.8 Sink Components

The east sink cold water shutoff valve is leaking and needs to be repaired.
