Beach to Bayou

PROPERTY INSPECTIONS

INSPECTION REPORT

100 Homeowner Street

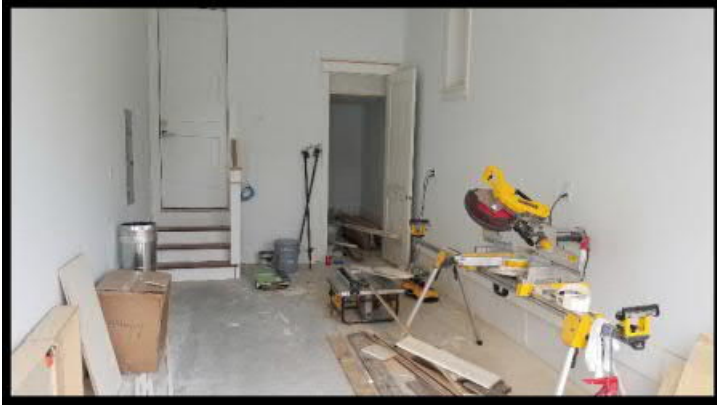
6.1 Unable to view all surfaces

Because of the owners belongings in the garage at the time of inspection, I was unable to fully inspect all surfaces of the garage. As I was unable to view all surfaces, I must exclude them from the report, and recommend you review this area at final walk-through (prior to close) for any deficiencies that may be concealed by the personal possessions.

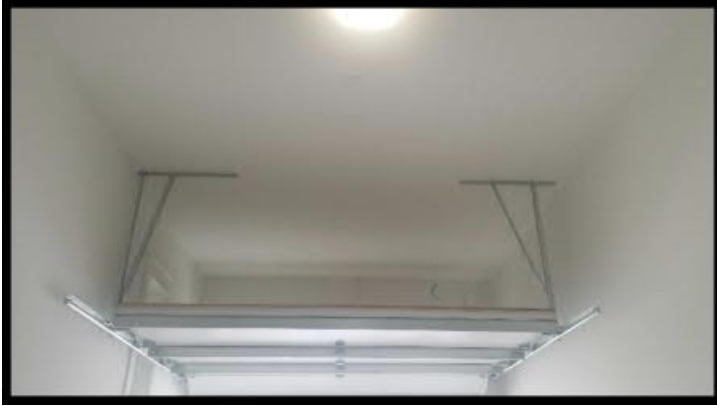
6.8 Automatic Opener

The automatic opener has not been installed and needs to be reviewed for defect once installation is complete.

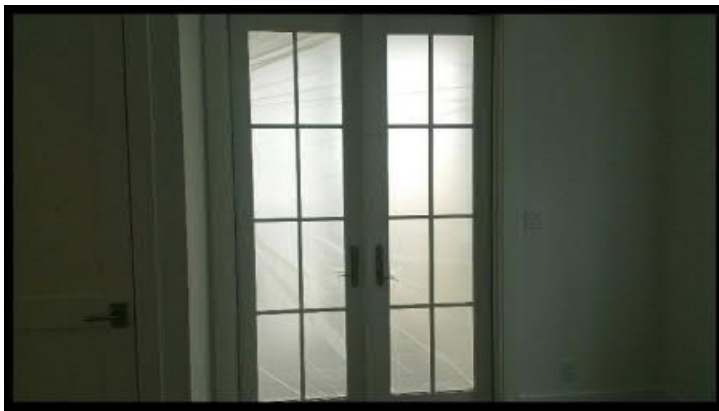
I was unable to inspect the exterior doors, as they were wrapped in plastic on the exterior. The doors should be reviewed once accessible.

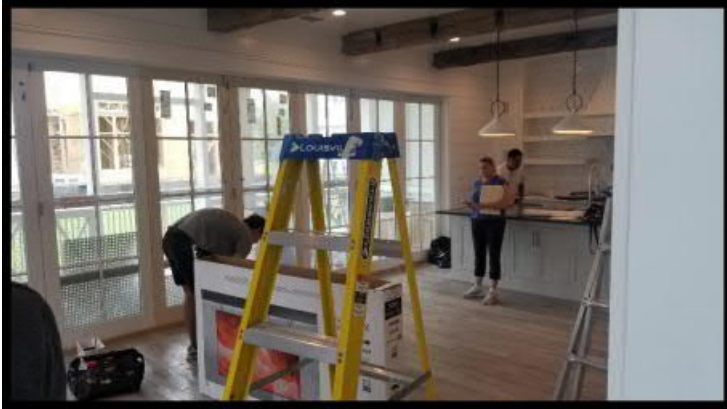
12.1 Unable to inspect all components

I was unable to inspect the Living/dinning room at the time of inspection due to ongoing construction. The room needs to be reviewed for defect once construction is complete.

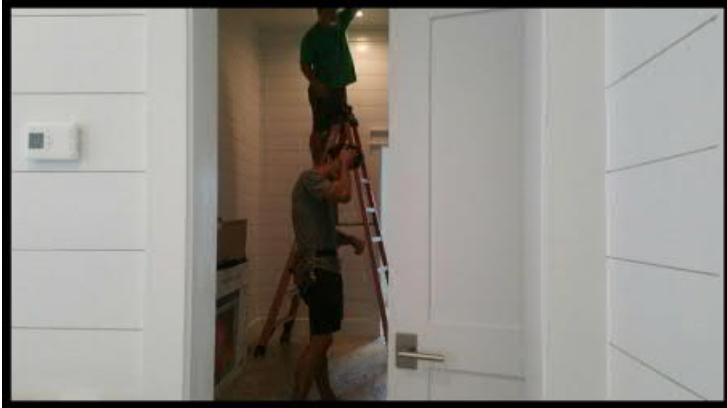
14.1 Unable to inspect all components

The hallway was under construction by AV contractors and was unable to be inspected. I recommend the area be reviewed once accessible.

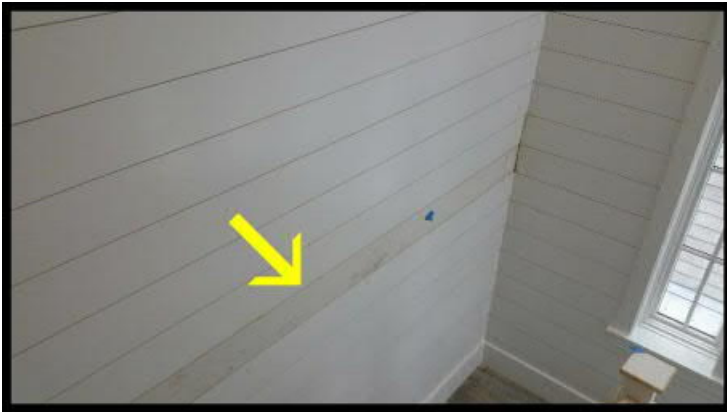
The walls and ceiling in the room have cosmetic damage or blemish.

A section of the wall is under repair and should be completed.

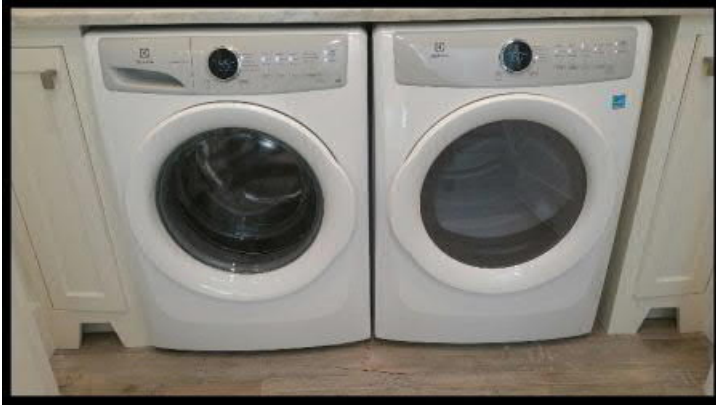
16.5 Obstructed Components

Due to the design of the laundry area, I was unable to view any of the appliance connections. Therefore, what was concealed, must be excluded from our inspection scope. If you have concerns about these areas, you should have them made accessible during your inspection period and reviewed for deficiencies.

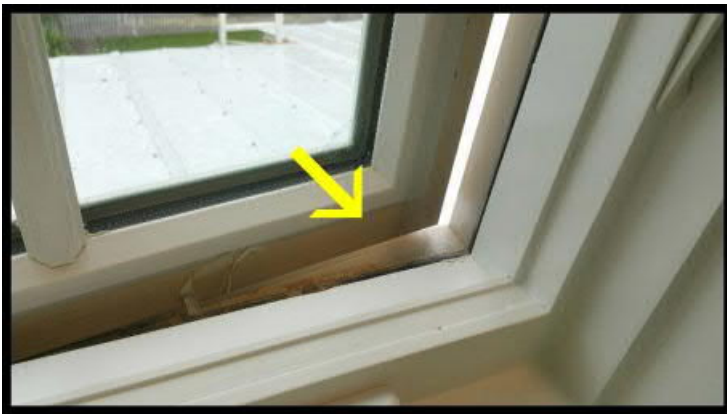
18.1 General Cosmetic Observations

The window frames are not fully painted. This is a cosmetic condition that should be further investigated and addressed as appropriate.

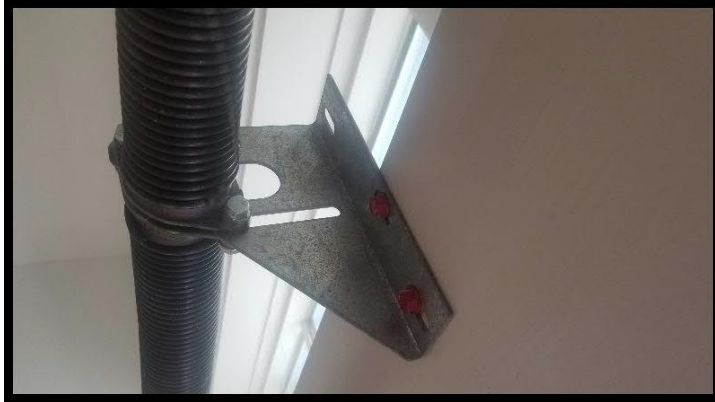
6.8 Automatic Opener

The automatic opener has not been installed and needs to be reviewed for defect once installation is complete.

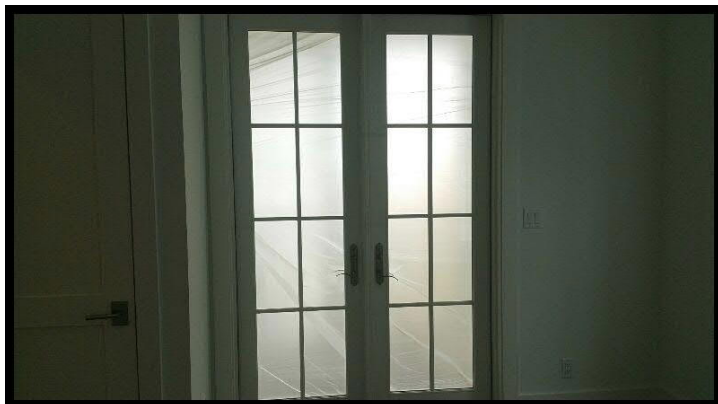
10.25 Doors

I was unable to inspect the exterior doors, as they were wrapped in plastic on the exterior. The doors should be reviewed once accessible.

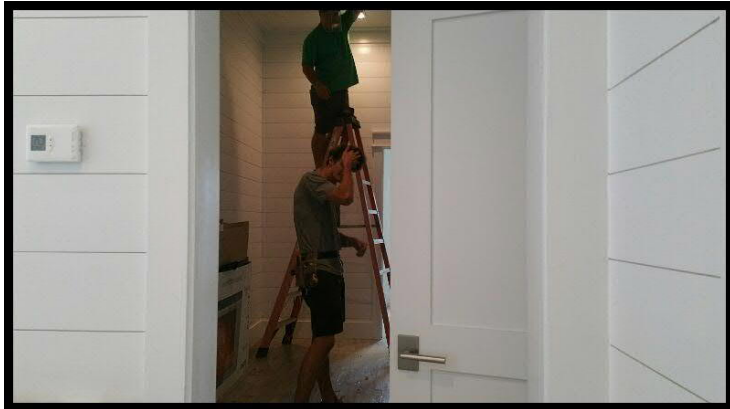
14.1 Unable to inspect all components

The hallway was under construction by AV contractors and was unable to be inspected. I recommend the area be reviewed once accessible.

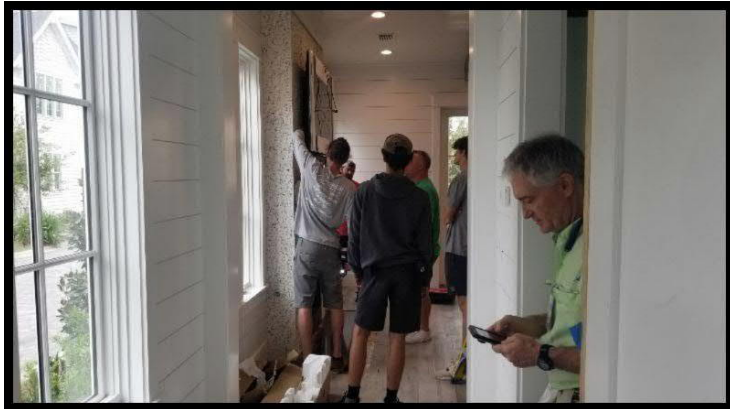
17.4 Fireplace

I was unable to inspect the fireplace at the time of inspection due to ongoing construction. The fireplace needs to be reviewed for defect once construction is complete.
