Joe Inspector
dba National Property Inspections

Jane Doe, 1234 Some Street, Some City, US, 00000

Inspection Date : 4/28/2008 Inspector: Joe Inspector
Inspector Phone: 999-999-9999

GENERAL INFORMATION

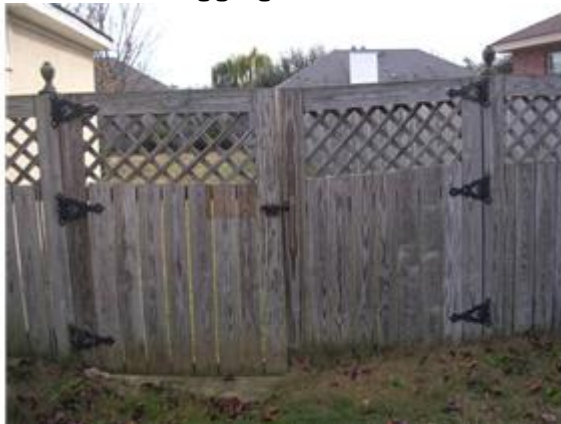
Comments : The south gates need to be repaired so they will open and close more easily .
 Recommend digging the dirt out from under the gate.

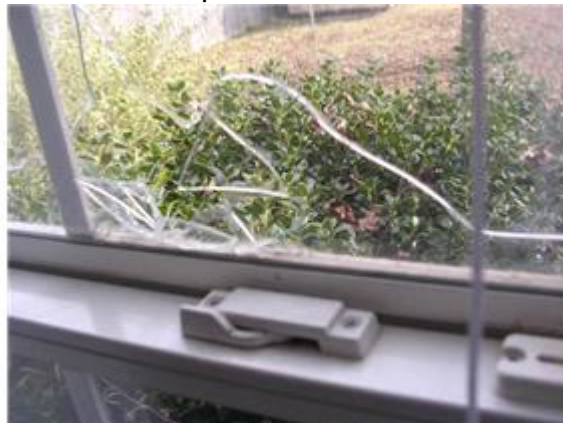
Comments : There is a broken window pane on the south window in the master bedroom that needs to be replaced.

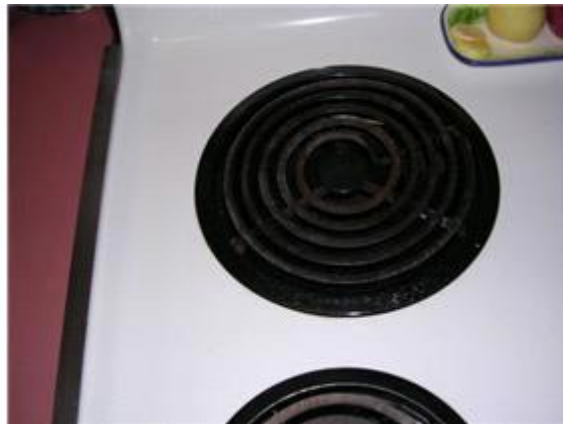
Comments : The back left burner on the stove top is not working. Everything else in the kitchen is in very good condition.

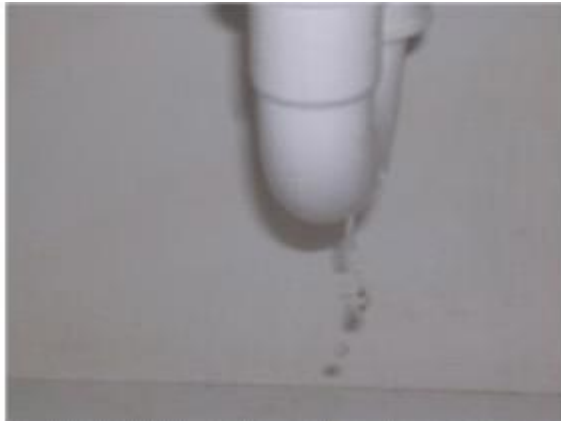
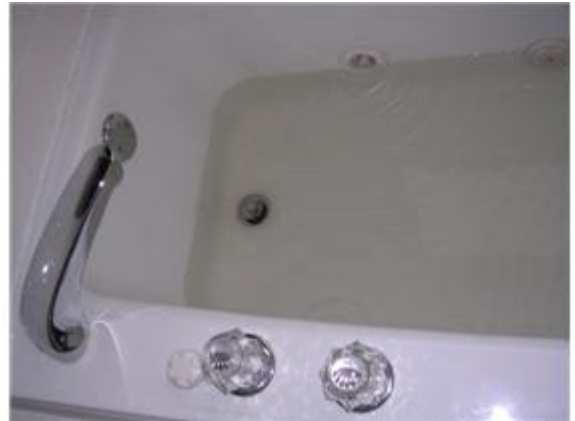
Comments : The bathtub is very slow to drain. The drain pipe under the sink is leaking. Everything else is in good condition.

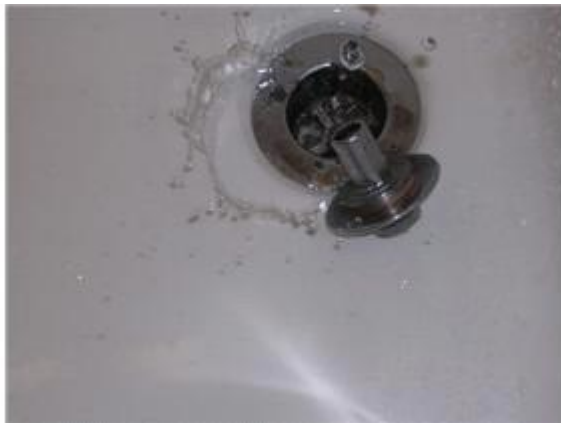
Comments : **Bathtub stopper is broken and needs to be repaired or replaced.**

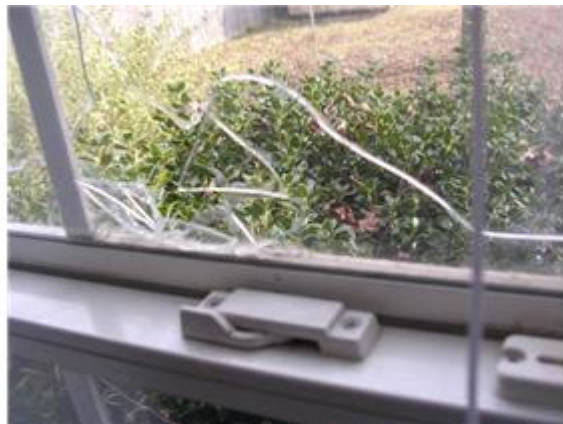
Comments : The south window has a broken pane. Everything else in the master bedroom is in very good condition.

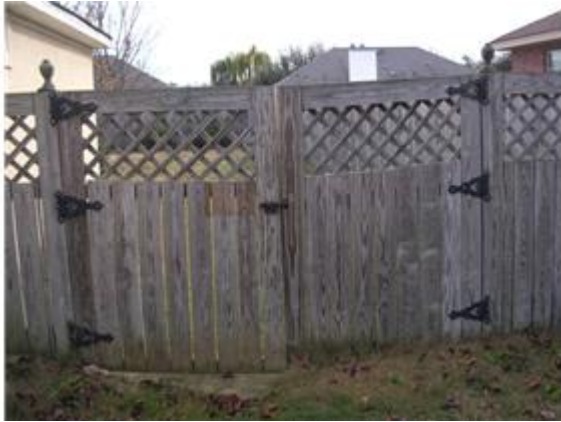
Marginal

The south gates need to be repaired so they will open and close more easily .
Recommend digging the dirt out from under the gate.

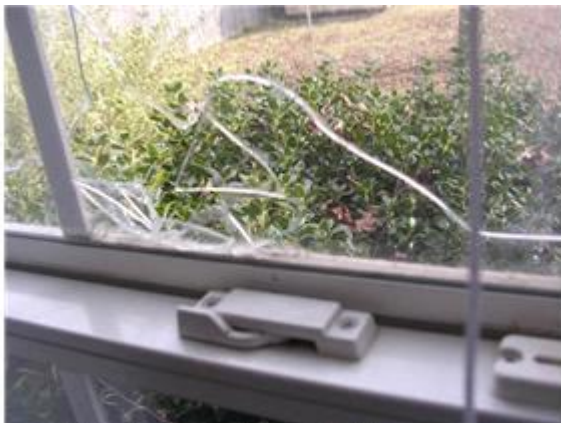
WINDOWS

Marginal

There is a broken window pane on the south window in the master bedroom that needs to be replaced.

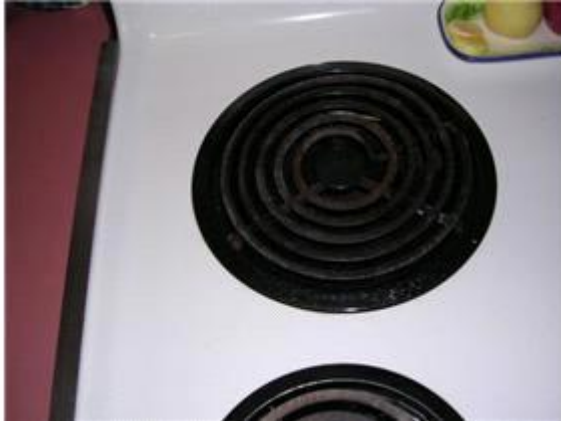
Defective

The back left burner on the stove top is not working. Everything else in the kitchen is in very good condition.

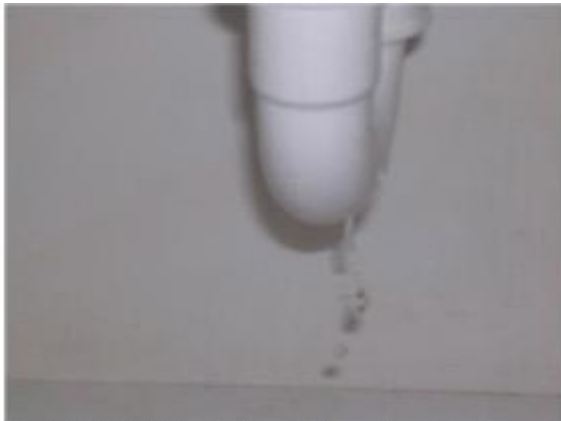
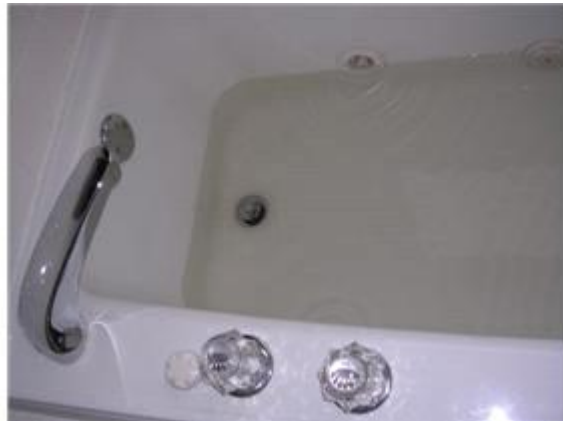
MASTER BATH

Marginal

The bathtub is very slow to drain. The drain pipe under the sink is leaking. Everything else is in good condition.

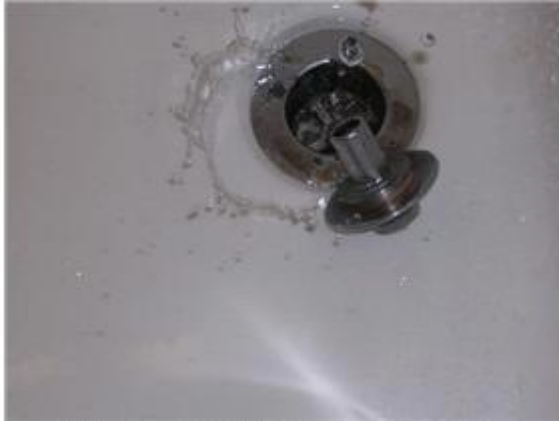
Marginal

Bathtub stopper is broken and needs to be repaired or replaced.

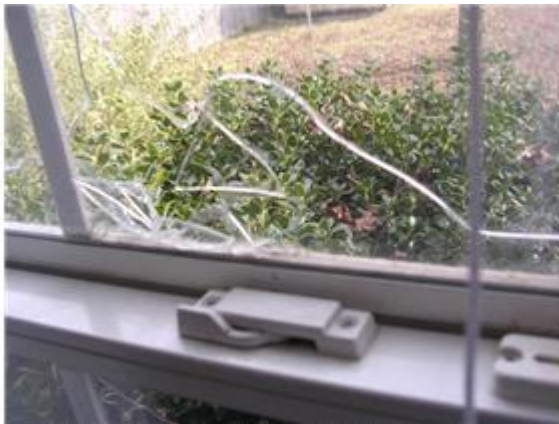
MASTER BEDROOM

Defective

The south window has a broken pane. Everything else in the master bedroom is in very good condition.
